Sample Inventory & Check In Report

123 London Road,
London,
N1 0PP

Visit date: March 9th 2021
Clerk: Property Inventories

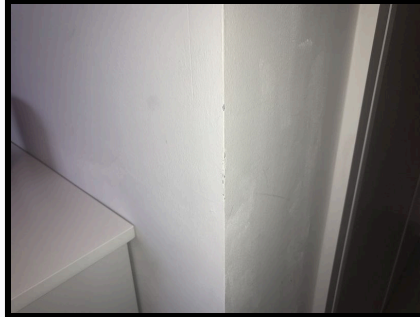
Ref # 6.4

Light rubs to mid level LHS to front door
Faint finger marks to mid level between bedrooms
Light angle chips to low level RHS to radiator
Shrinkage cracking to high level LHS to built in cupboard frame

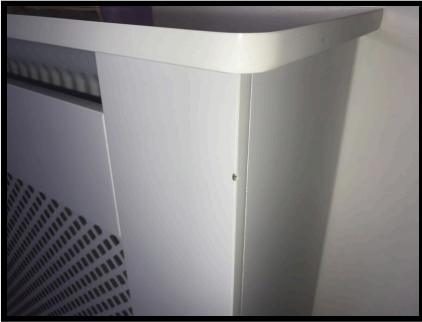
Ref # 6.9

Angle chip to RHS edge
Top panel slightly loose
Tenant's contents to top

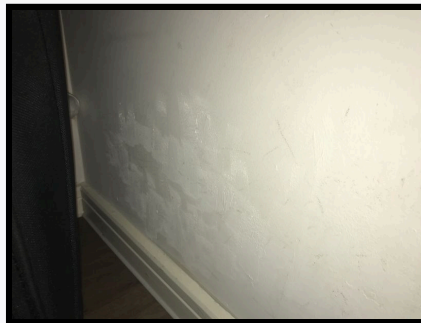
Ref # 6.14

Not fully examined due to contents
Light rubs to rear wall
Possible repair marks to low level RHS wall

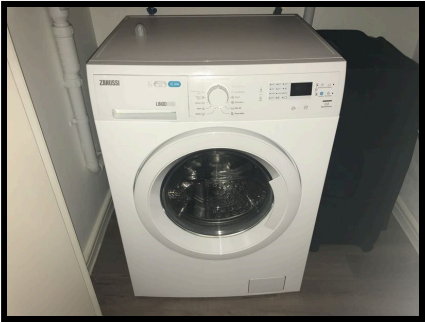
Ref # 6.16

NT
Light soap residue to tray
White residue to door seal
Brown stain to control panel

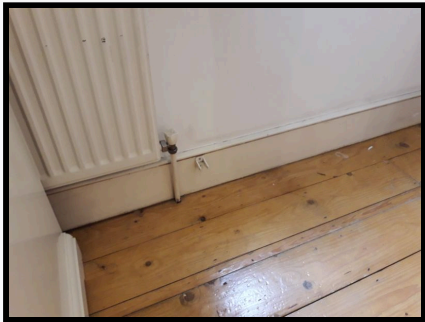
Ref # 7.18

Not fully examine due to furnishings
Notable wear forward of entry door
Scratches
Gapping to edges of boards
Light debris

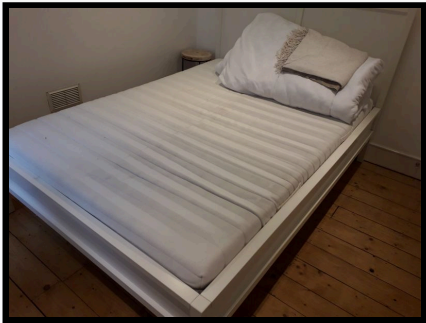
Ref # 7.19

Appears slightly unstable
Light wear
Slightly dusty
2 Chips to centre of headboard
Not fully examined due to position
Slight gaps to joins to headboard and bed frame

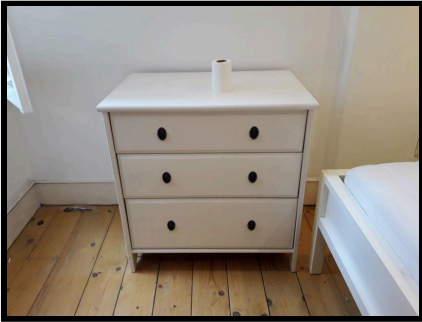
Ref # 7.22

Slightly unstable
Scattered angle chips to top
Light wear
Usage marks
Light scratches to some drawer bases

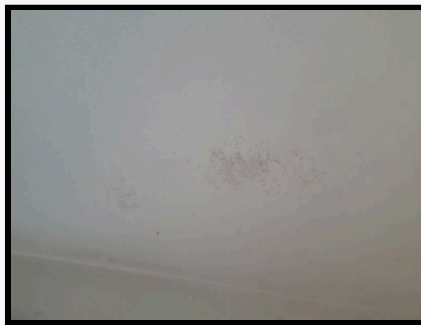
Ref # 8.5

Slight patchy paintwork
Brown mark forward of entry door
Light mould spots above basin with dark marks nearby
Residue spots above window
Residue spots above bath
Paint cracking above bath taps
Light shrinkage cracking along the edge above the bath taps

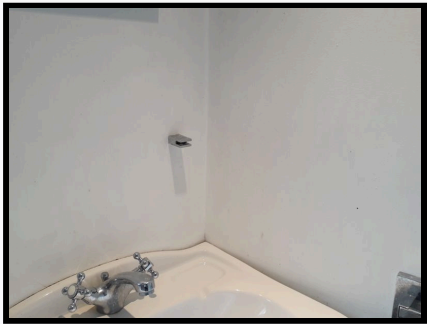
Ref # 8.7

Patchy paintwork
Scattered light rubs
Residue marks, paint cracking and drip marks to mid level above the basin
Faint brown spots to high level RHS of basin
2 Dark discoloured lines above the toilet cistern
Faint drip marks below window sill to LHS
Brush strokes visible LHS of window
Painted over nail above radiator
Brown mark above radiator
Notable patchy paintwork behind radiator
Brown drip marks to mid level RHS of radiator
Drip marks below basin
Paint flaking to low level below towel rail

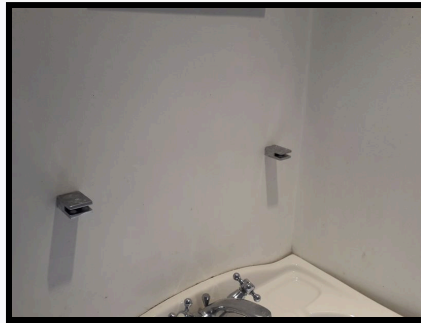
Ref # 8.10

No shelf in situ
Excess paint
Light residue
RHS bracket slightly loose
Water marks

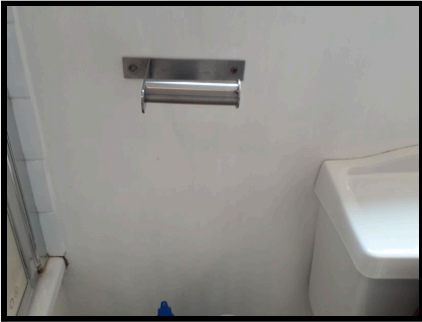
Ref # 8.13

Loose to wall
Light rust around screws

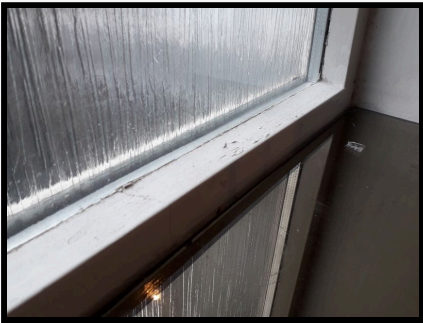
Ref # 8.14

Light paint flaking
White residue to glass
Scattered paint chips and light shrinkage cracking to joins
Brown residue spots to high level frames
Notable chips and tarnishing to handle

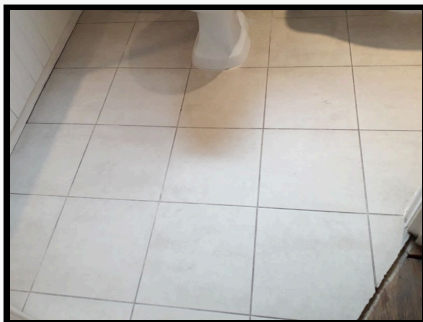
Ref # 8.20

8.20 Tiles	Beige Grey grout	Discolouration to grout Residue Hair residue Cracks and gapping to grout forward of toilet Not fully examined due to furnishings
------------	---------------------	--

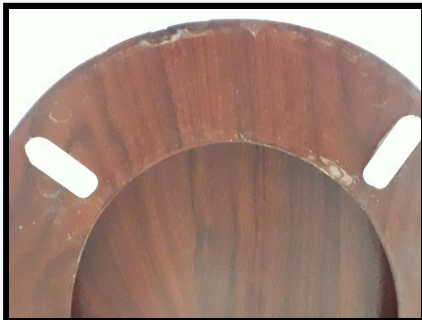
Ref # 8.22

White residue to underside of seat
Small crack to 1 seat buffer
Hinges slightly loose
Light cracks to veneer to front edge of lid

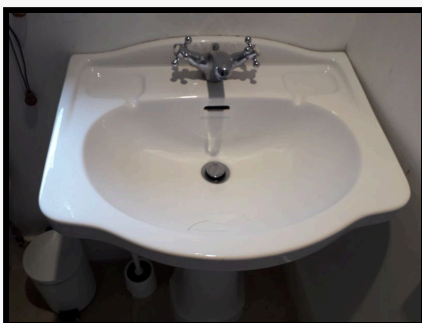
Ref # 8.23

Light soiling
Notable cracks to base of basin
Water marks to chrome fittings
Light soiling to interior of overflow
Gapping to rear sealant behind taps

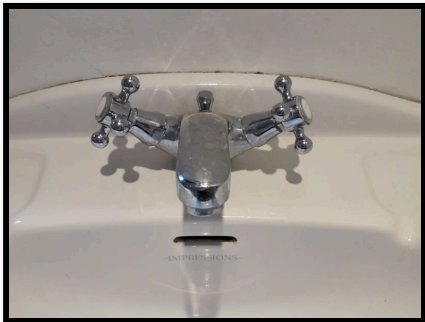
Ref # 8.24

Plug adjuster NW
Cracks to inserts
Water marks and light limescale to recesses

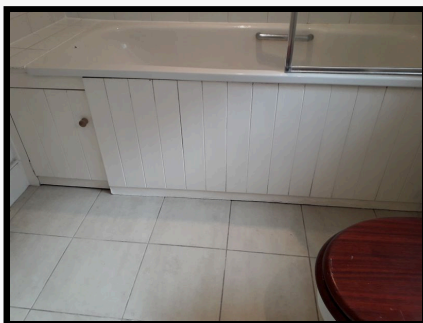
Ref # 8.28

Light shrinkage cracking between panels
Slight discolouration to recesses of some panels
Light wear to finger pull of door
Paint flaking and cracks to low level
Scattered paint chips
Slight water penetration

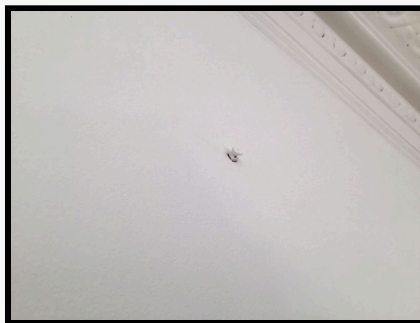
Ref # 9.8

Light painted over defects
Painted over screw forward of entry door
Brown residue to low level below LHS floating shelf

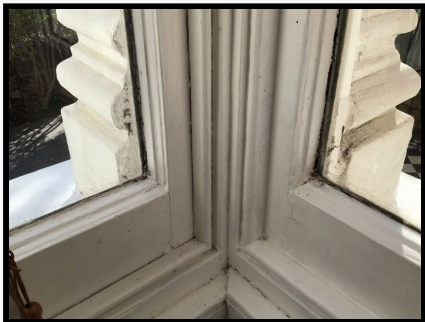
Ref # 9.10

1.5 Condition / Cleanliness	Scattered cracks to some reception window glass panels
Blinds / Curtains	
1.6 Condition / Cleanliness	Brown water stains to reception curtains
Woodwork

Cords seen to 3 of the windows
Scattered cracks to some glass panels
Light exterior weather soiling
Light mildew and excess paint to edges of all glass panes
Light shrinkage cracking to frames in places
Hole with cabling to low level RHS

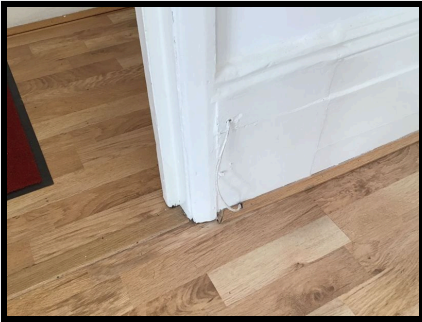
Ref # 9.19

Painted over defects
Hole with cabling RHS of entry door

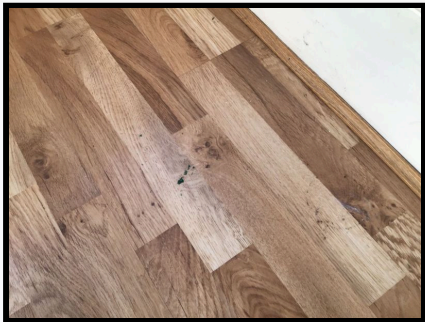
Ref # 9.20

Light debris
Excess paint spots to beading in places
Seams visible to beading
Light gapping in places to beading
Scattered light rubs
2 Pieces of brown tape forward of window
Circular residue and green spot stains forward of window to RHS
Blue stain forward of fireplace
Scattered residue marks
Tarnishing to air vents

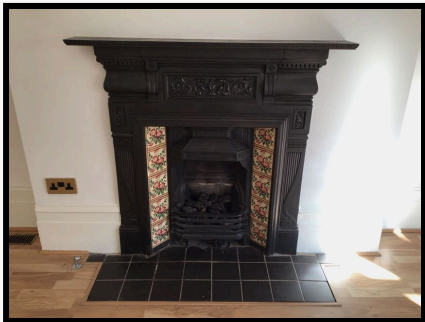
Ref # 9.21

Ring marks, white marks and brown marks to top of mantel
Tiles aged
Light residue spots to tiles
White splash marks to low level
Red candle wax to plinth
Cracked tile and chipped tile to LHS
Light dust, residue spots and wax residue to plinth
Light gapping between plinth and wooden surround with slight gapping to joins of surround

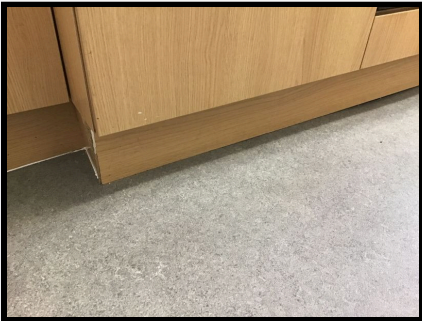
Ref # 10.26

Seam to kickboards forward of window
Gapping to both edges at both ends
Sealant missing to long panel below oven

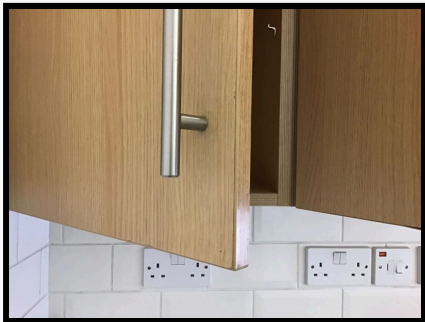
Ref # 10.27

1 Shelf appears missing from far LHS unit
Postal items to interior of far LHS unit
Slight swelling and angle chip to low level RHS corner of door to far LHS unit
Light usage marks
Trim to bottom edge of middle unit is detaching slightly
Scattered residue spots

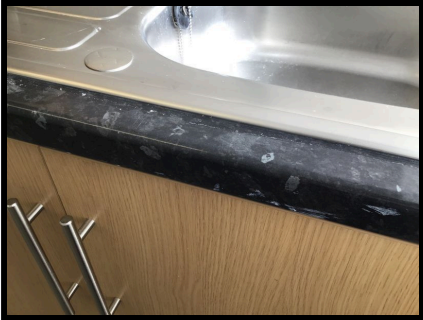
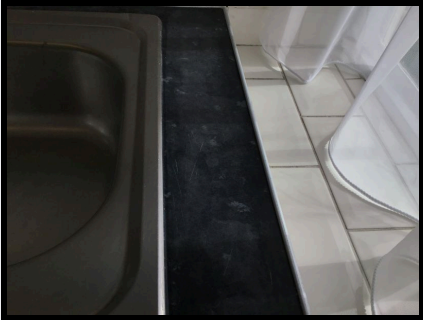
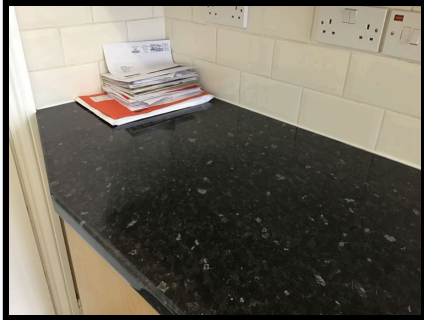
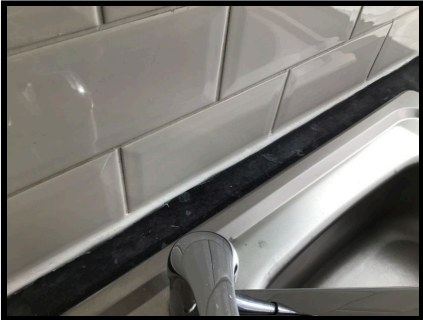
Ref # 10.30	Ref # 10.30	Ref # 10.30

10.29 Drawers	Cluster of 3	
Worktops & Splashbacks		
10.30 Worktop	Black speckled laminate Grey metal trim	Postal items to top Knife marks Scattered residue marks White discolouration to rear and RHS of sink Excess sealant to sink front edge Scattered white marks to sink front edge Light wear to trim

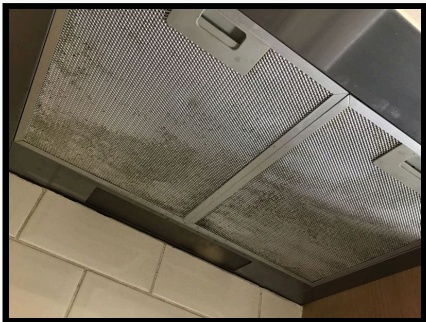
Ref # 10.34

1.9 Condition / Cleanliness	Good order Stains to bedroom 1 mattress
Cooker Hood	
1.10 Condition / Cleanliness	NT Dark discolouration and warping to filters
Hob

Dark discolouration and warping to filters
NT

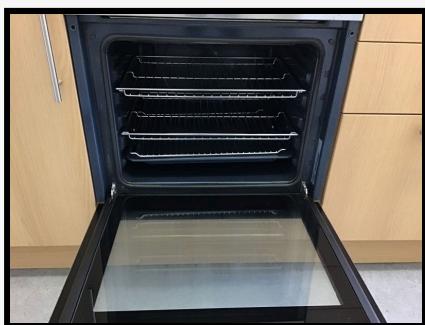
Ref # 10.36

Oven	
1.12 Condition /Cleanliness	Light smears and scratches to exterior chrome by dials Light residue to RHS dial Decals fading Run marks and food residue to window Light burnt on grease to interior and fittings
Fridge Freezer	
1.13 Condition / Cleanliness	Lights in WO Light usage marks Dents with chipping and light wear to low level exterior fridge door Crack with piece missing to top freezer drawer
Washing Machine	
1.14 Condition / Cleanliness	NT Light soap residue to tray Cross-shaped scratch above control panel to RHS Few scattered scratches to top
Dishwasher	
1.15 Condition / Cleanliness	None
Exterior Areas	
1.16 Garden / Front Approach / Balcony	None

Light smears and scratches to exterior chrome by dials
 Light residue to RHS dial
 Decals fading
 Run marks and food residue to window
 Light burnt on grease to interior and fittings

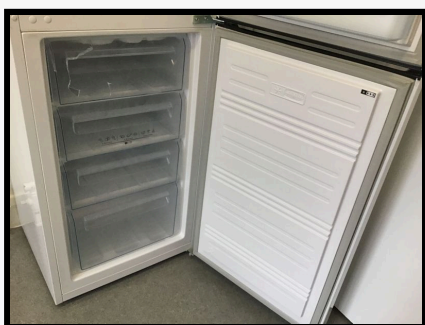
Ref # 10.37

Lights in WO
 Light usage marks
 Dents with chipping and light wear to low level exterior fridge door
 Crack with piece missing to top freezer drawer

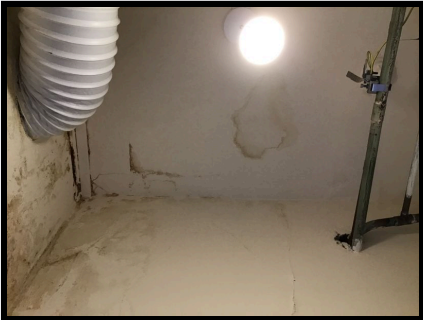
1.2 Decorative Order	The property is shown in a fair decorative order with marks and defects where noted in the report <i>Notable brown water stains to utility room to utility room ceiling and walls</i> <i>Heavy discolouration, paint bubbling and brown water stains to utility room window reveals</i>
Lighting

Ref # 11.1		
11.2 Door frame	Painted white wood	Light painted over defects
Door Fixtures		
11.3 Finger pull	Painted over	
Ceiling		
11.4 Ceiling	Painted cream	Notable brown water stains to ceiling

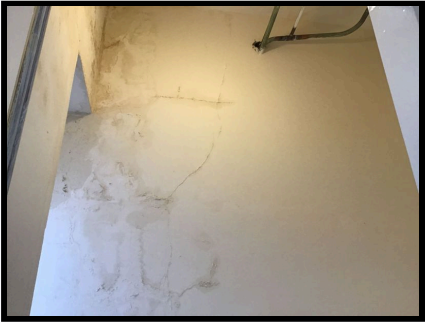
Ref # 11.6

Ref # 11.4		
Ceiling Mounted Fixtures		
11.5 Pendant light	White plastic	WO
Walls		
11.6 Painted	Cream	Heavy brown water stains and bubbling Discolouration throughout

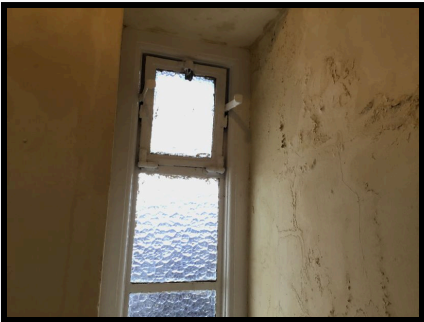
Ref # 11.10

Mildew to edges of glass
Excess paint to edges of glass
Painted over defects to frame
2 Pin holes to low level frames

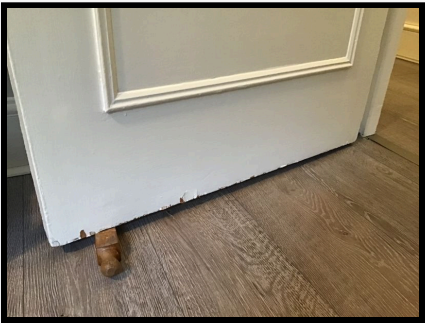
Item	Description	Condition
Door & Architrave		
12.1 Door	Painted white wood 2 Recessed panels Fire chain	Notable slivering to low level exterior - lighter to interior Painted over defects

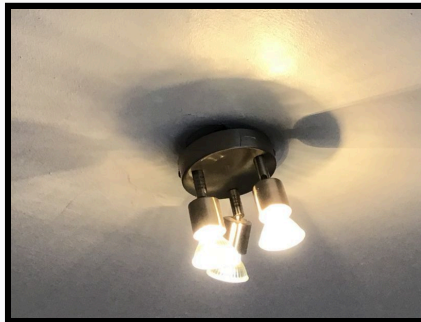
Ref # 12.7

1.3 Condition / Cleanliness	WO Notable gapping to bedroom 2 light fixture
Smoke / CO Alarms	
1.4 Condition / Functionality	All tested and in WO
Windows & Frames

12.7 Light fixture with directional spotlights	Chrome 3 Spotlights	WO Notable gapping -- hanging loose
--	------------------------	---

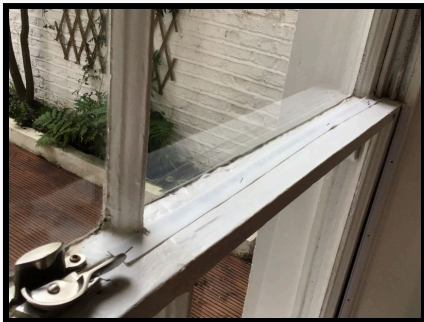
Ref # 12.11

Excess paint to edges of glass
Both cords intact
Painted over defects to frames
Excess paint to fixtures
White plastic stapled to mid level - possibly to reduce draft
Clear plastic cleat hook to LHS reveal

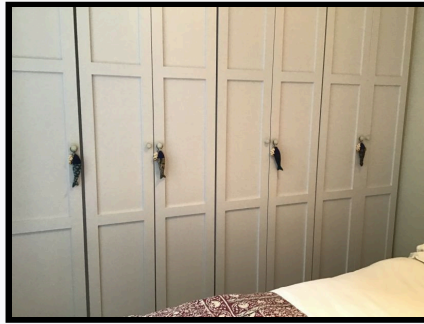
Ref # 12.19

4 Fish-shaped fobs and shells with bells hanging from some finger pulls
Double doors to far RHS currently locked - unable to examine interior
Light rubs to interiors of doors
Light painted over defects
2 Low level hinges on 2nd door from LHS appears detaching
Light scratches around finger pulls

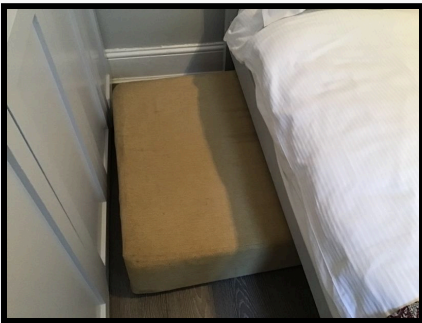
Ref # 12.48

Stains and wear
Appears that it could be part of a sofa
