## Mid-term Report

[ADDRESS]

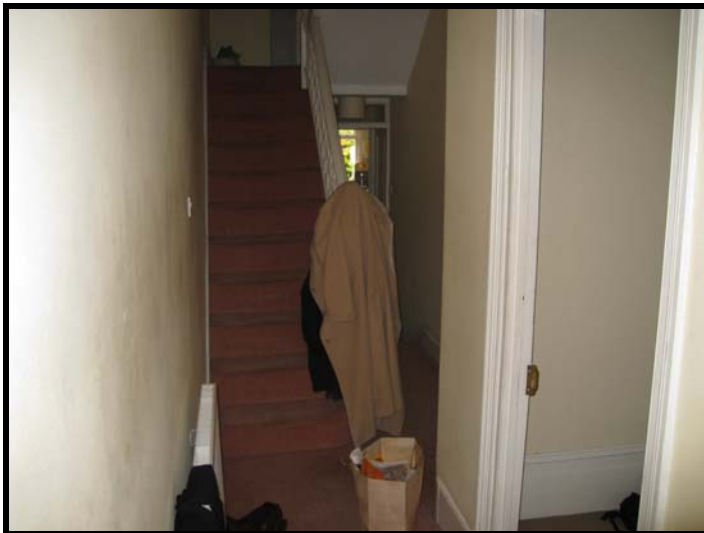
**Overview Photo:**

Showing many signs of use to walls and woodwork

Shrinkage at high level  
Low level scuffs and some finger soiling

Scuffs to fascia

Some shrinkage to top edge and other usage marks

Tread wear and slight shading

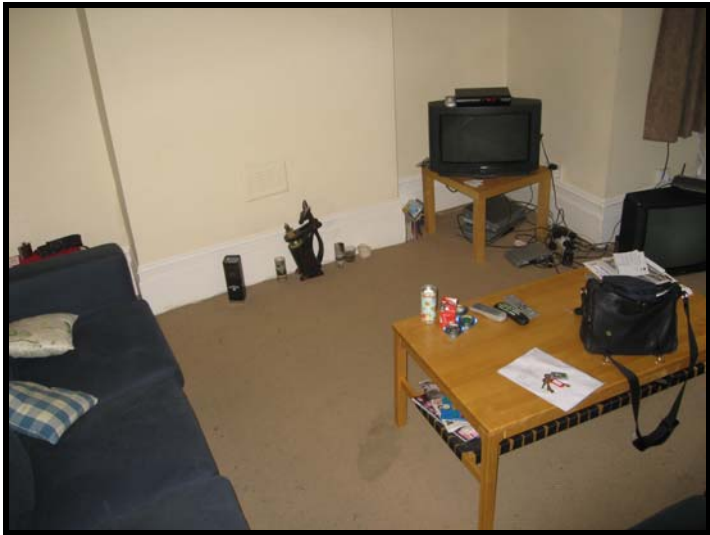
**Overview Photo:**

Overall in good order with various usage marks

Walls		Low to mid level usage marks		
Floors		Some large stains to carpets		
<b>Decorative Order</b>	Excellent	Good	Fair ✓	Poor
<b>General Cleanliness</b>	Excellent	Good	Fair ✓	Poor

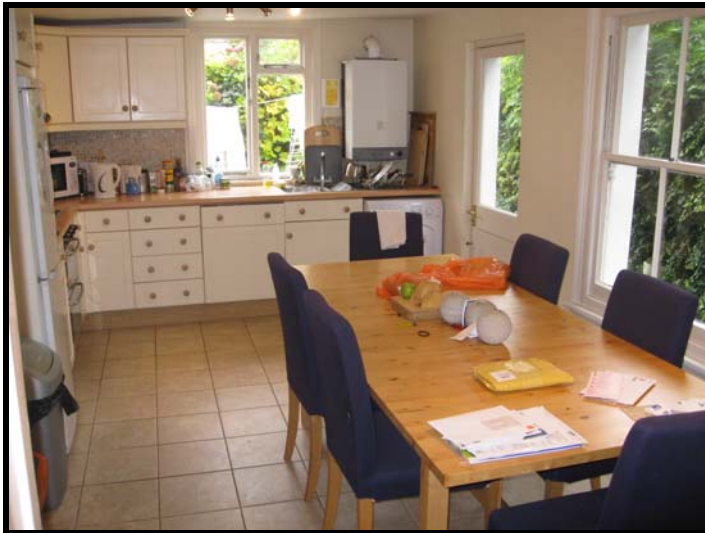
**Overview Photo:**

Maintenance inspection needed, possible water damage from bathroom above

Ceiling		<b>Water damage</b> and spot stains		
Walls		<b>Water damage</b> , shrinkage cracking present		
Wall cabinets		Handle missing		
<b>Decorative Order</b>	Excellent	Good	Fair ✓	Poor
<b>General Cleanliness</b>	Excellent	Good ✓	Fair	Poor

- The areas of damp, mould and flaking paint as noted
- The broken extractor fan in the bathroom
- The detached door handles as noted

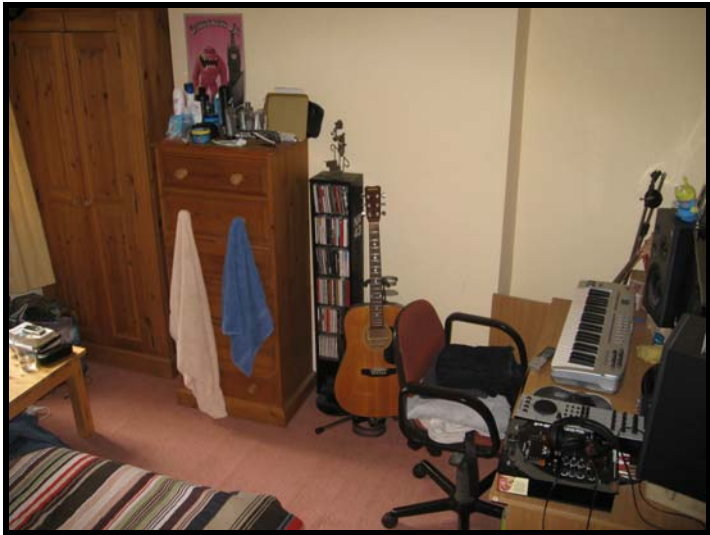
**Overview photo:**

In good order with only minor marks seen

Minor usage marks low to mid level

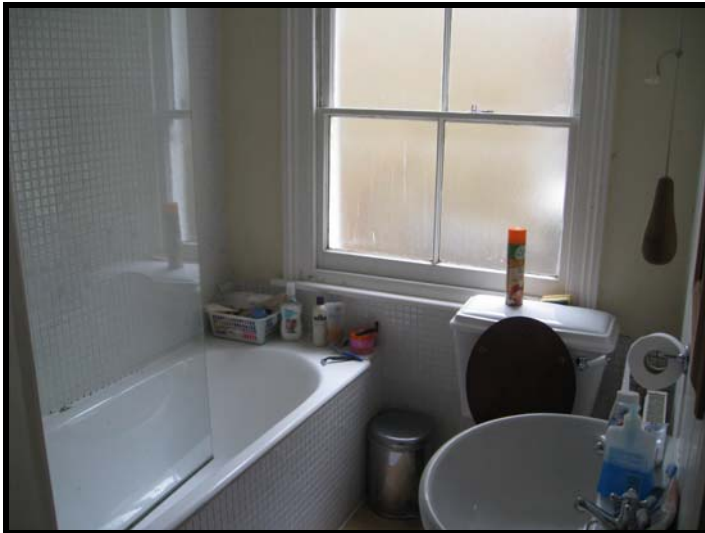
**Overview photo:**

Seen in a fair condition with some light maintenance required

Ceiling		<b>Damp and mould marks</b>			
Walls		Defects around extractor fan, <b>some low level possible damp below window</b>			
Window frame		<b>Heavy paint flaking</b>			
Bath		Sealant discoloured and lifting slightly, <b>possibly leaking</b> , screen not sitting flush on side of bath			
<b>Decorative Order</b>	Excellent	Good	Fair ✓	Poor	
<b>General Cleanliness</b>	Excellent	Good	Fair ✓	Poor
