Property Inventories

## Sample Schedule of Condition

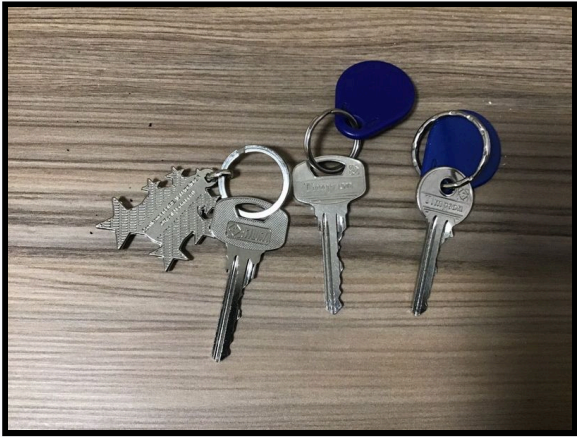
| Ref | Name | Keys |

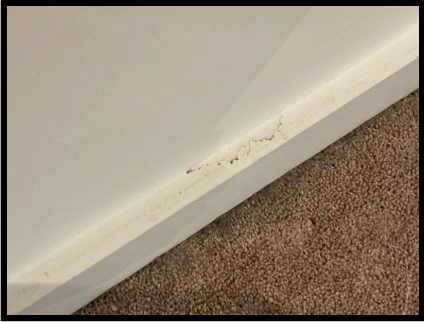
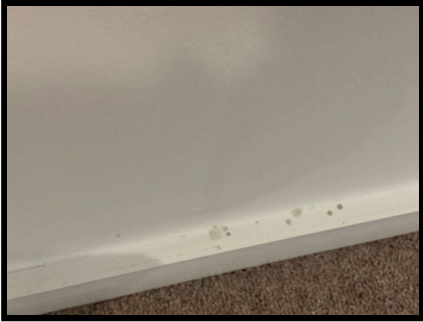
| Ref | Name | Rating | Comments |
|---|---|---|---|
| <div><div><div>Ref #5.13</div></div><div><div>Ref #5.13</div></div></div> | | | |

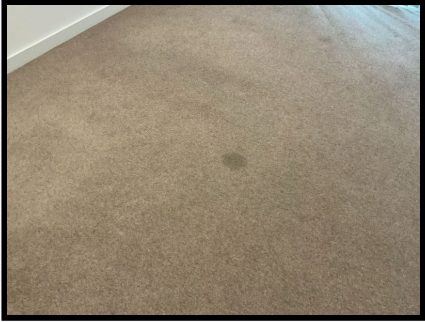
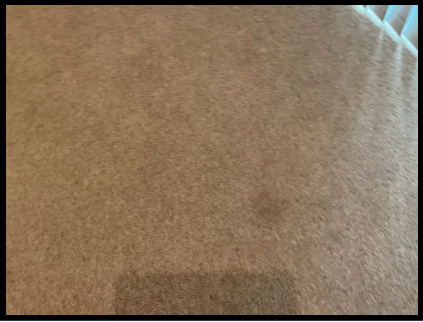
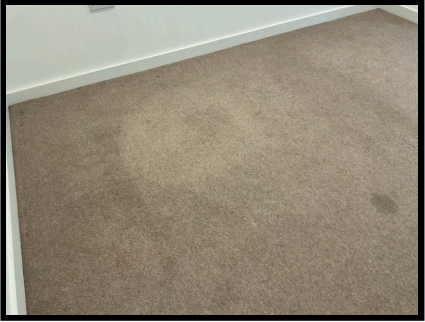
| Ref | Name | Rating | Comments |
|---|---|---|---|
| <div><div><div>Ref #5.14</div></div><div><div>Ref #5.14</div></div><div><div>Ref #5.14</div></div></div> | | | |

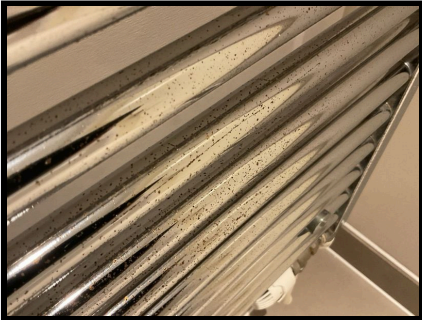
| Ref | Name | Rating | Comments |
|---|---|---|---|
| <div><div></div><div>Ref #6.9</div></div> | | | |

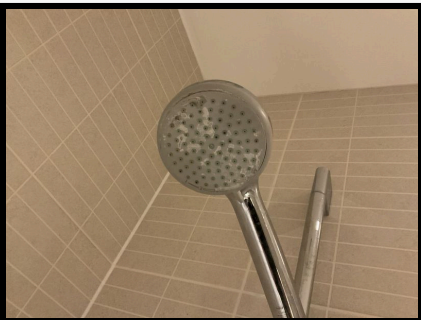
| Ref | Name | Rating | Comments |
|---|---|---|---|
| <div><p>Ref #6.18</p></div> | | | |

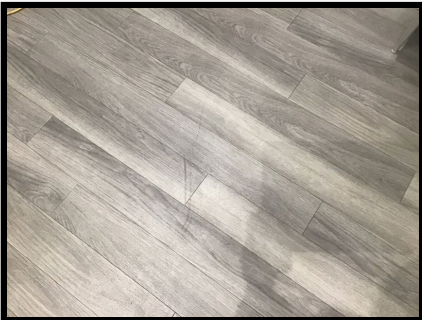
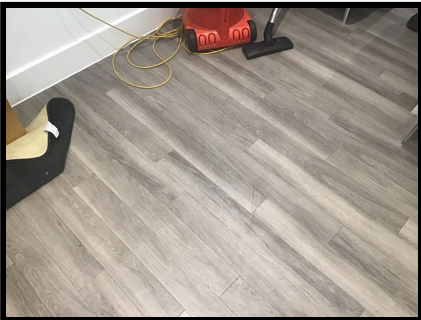
| Ref | Name | Rating | Comments |
|---|---|---|---|
| <div><div><div><p>Ref #7.15</p></div><div><p>Ref #7.15</p></div></div></div> | | | |

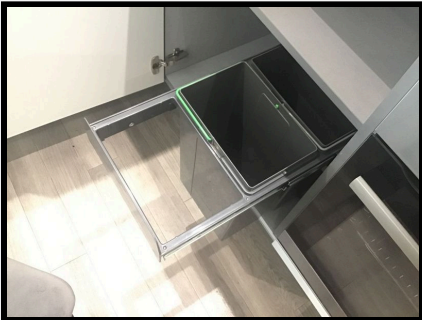
| Ref | Name | Rating | Comments |
|---|---|---|---|
| <div><div><p>Ref #7.16</p></div></div> | | | |

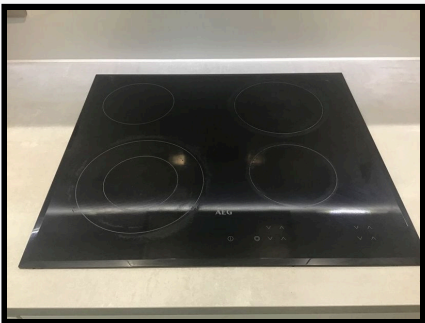
| 7.21 | Hob | FAIR | Light wear<br>Burnt on residue |

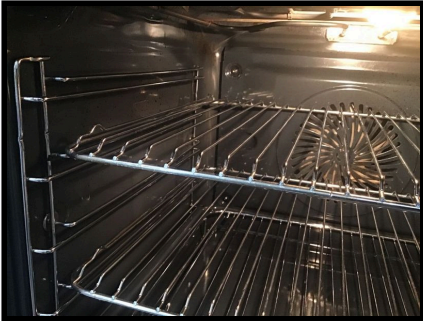
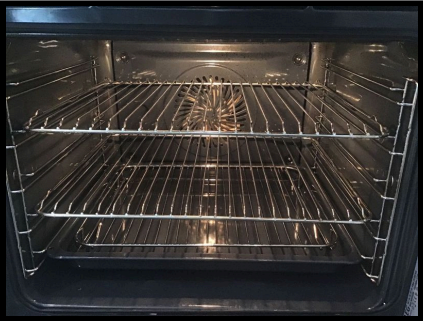
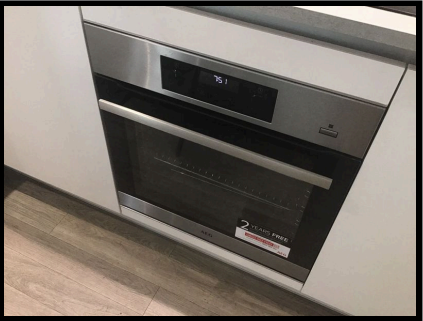
| Ref | Name | Rating | Comments |
|---|---|---|---|
| <div><div><div><div>Ref #7.22</div></div><div><div>Ref #7.22</div></div><div><div>Ref #7.22</div></div></div></div> | | | |

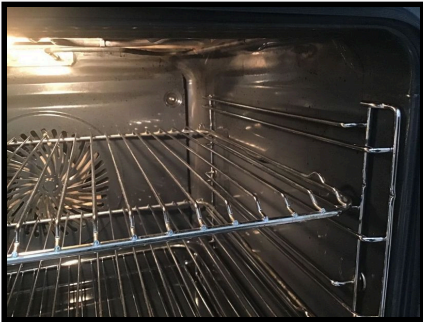
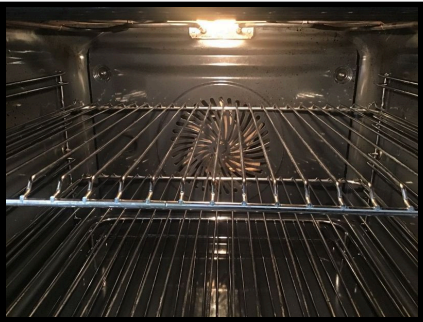
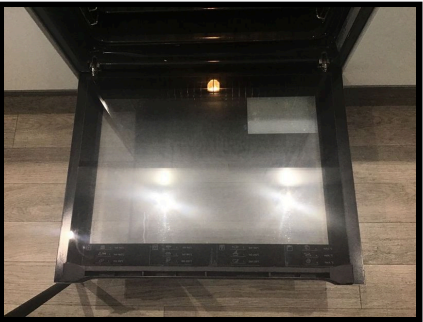
| Ref | Name | Rating | Comments |
|---|---|---|---|
| <div><div><div><div>Ref #7.22</div></div><div><div>Ref #7.22</div></div><div><div>Ref #7.22</div></div></div></div> | | | |

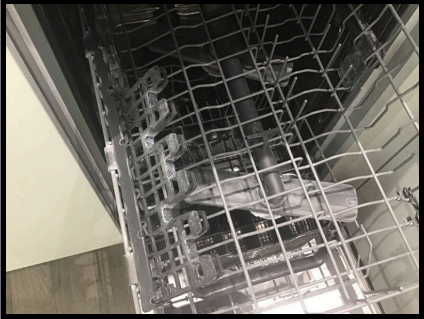
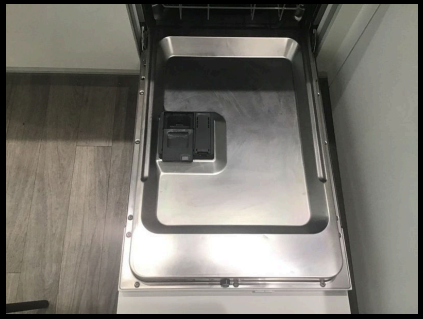
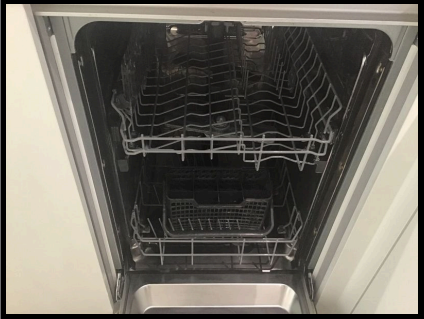
| Ref | Name | Rating | Comments |
|---|---|---|---|
| <div><div><p>Ref #7.24</p></div><div><p>Ref #7.24</p></div><div><p>Ref #7.24</p></div></div> | | | |

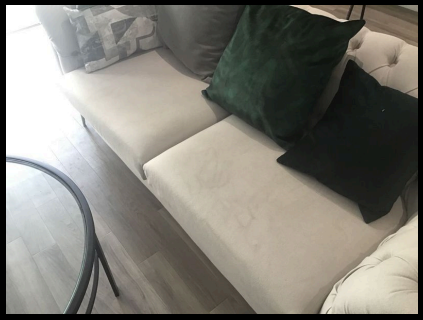
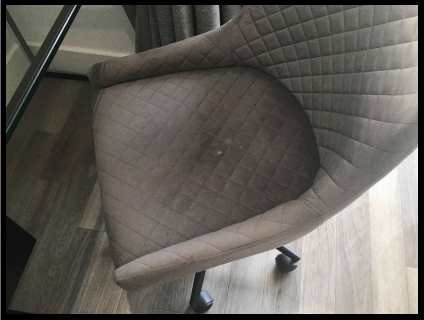
| Ref | Name | Rating | Comments |
|---|---|---|---|
| <div><div><p>Ref #7.26</p></div><div><p>Ref #7.26</p></div><div><p>Ref #7.26</p></div></div> | | | |
