Property Inventories

123 Sample Street,
Sample City,
Sampleshire,
AB1 2CD

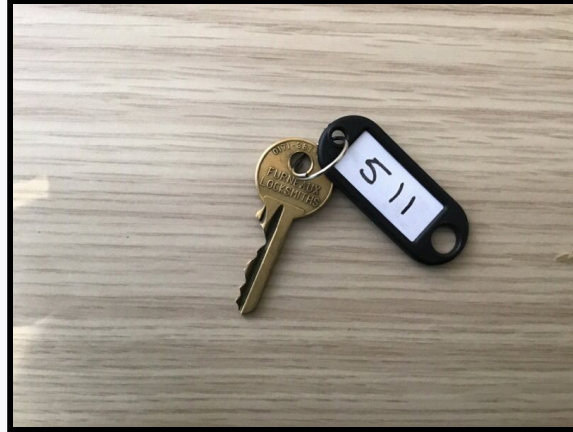
Ref	Name	Keys at Inventory	Keys at Check Out
2.1	Front door	1 Yale	<i>As Inventory</i>

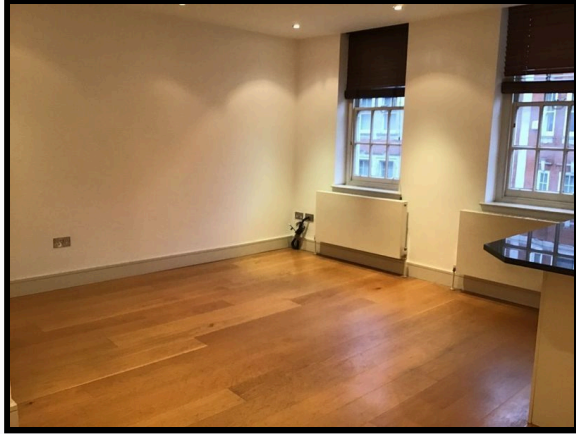
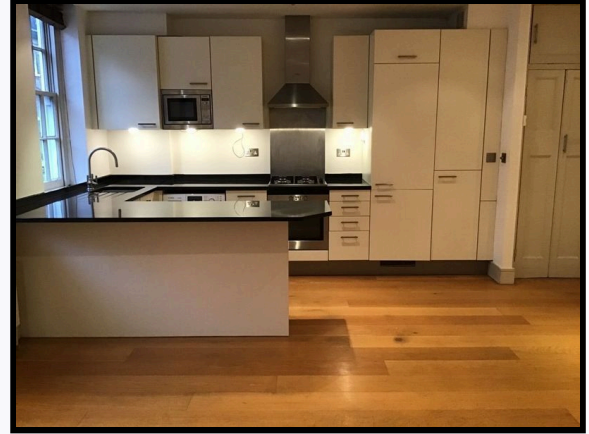
Ref	Name	Description	Condition at Inventory	Condition at Check Out
Ceiling				
5.1	Ceiling	Painted white		
Ceiling Mounted Fixtures				
5.2	Recessed spotlights	14 White plastic	2 NW Gapping	<i>As Inventory + All bulbs now seen in WO</i>
5.3	Sprinkler	White plastic		
5.4	Smoke alarm	White plastic	Tested and in WO	<i>As Inventory</i>

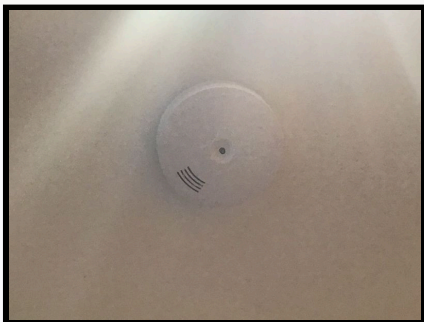
<p>Ref # 5.4</p>				
Walls				
5.5	Walls	Painted white	Rubs and light marks in places Heavier below telephone jack Scuff above entry phone Paint chips above entry phone	<i>As Inventory + 4 White plastic hooks high level LHS entry</i> Explain/Remove - Tenant

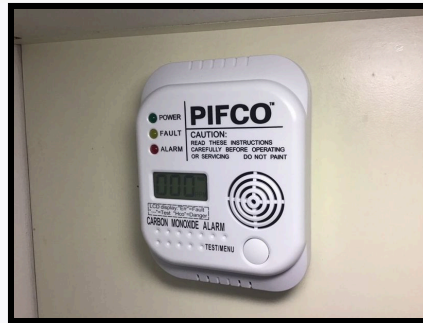
5.10	Board	Pink and grey fabric	Photos pinned to top	Not seen Explain/Replace - Tenant
5.11	Carbon monoxide alarm	Pifco White plastic	<i>Item added after Check In</i>	<i>Not previously mentioned</i> Tested and in WO

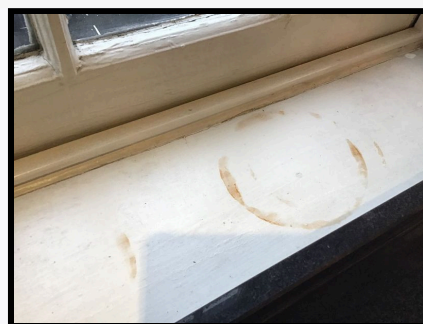
5.12	Sash window	3 Painted white wood Painted white fixtures	Cords intact Exterior weather soiling Painted over defects	<i>As Inventory</i>
5.13	Reveals	As walls	Rubs to RHS of RHS window	<i>As Inventory</i>
5.14	Sills	Painted white wood		Brown ring marks to RHS sill Clean - Tenant

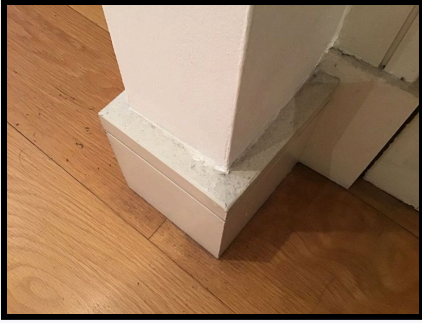
Ref # 5.18				
Flooring

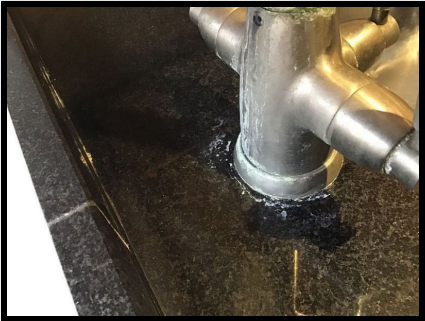
<p>Ref # 5.25</p>				
5.26	Upstand	As worktop		
5.27	Splashback	Chrome		
Sinks / Taps				
5.28	Single bowl sink with waste and overflow	Stainless steel		
5.29	Mixer tap with dual control	Chrome	Water marks Limescale to spout	<i>As Inventory +</i> Limescale to recesses Clean - Tenant

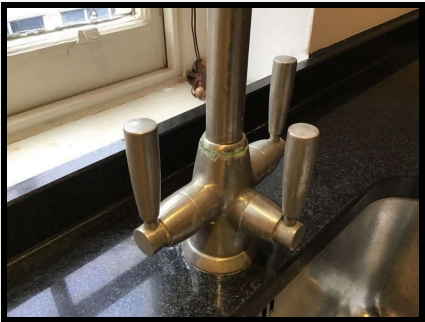
<p>Ref # 5.29</p>				
Appliances				
5.30	Cooker hood	Chrome Siemens Filter 2 Lights	Fan and lights in WO	<i>As Inventory +</i> 1 Light NW Light grease to edges of underside Filter sticky to touch Replace Bulb - Tenant Clean - Tenant

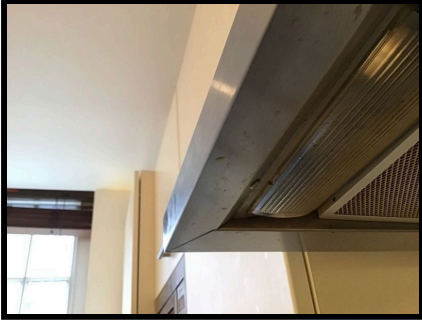
5. Kitchen / Reception (Cont.)

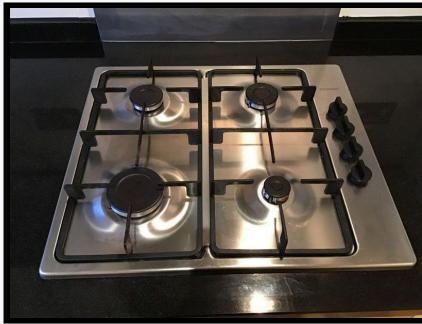
As Inventory +
Light burnt on grease to
edges of 1 burner
Clean - Tenant

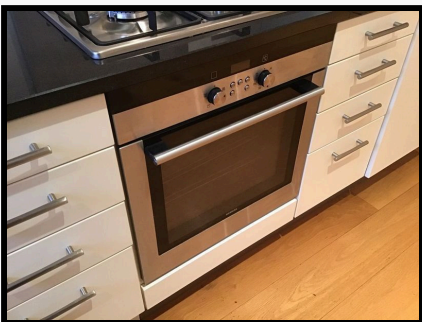
Contents:
2 Chrome tracks
2 Chrome racks
Grey metal baking tray
Chrome trivet

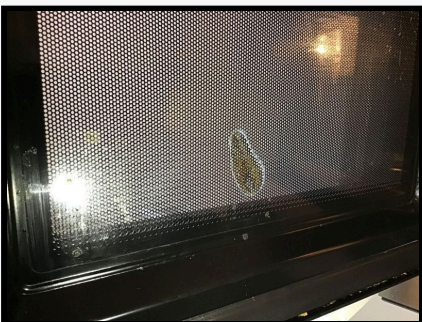
Explain/Repair -
Tenant

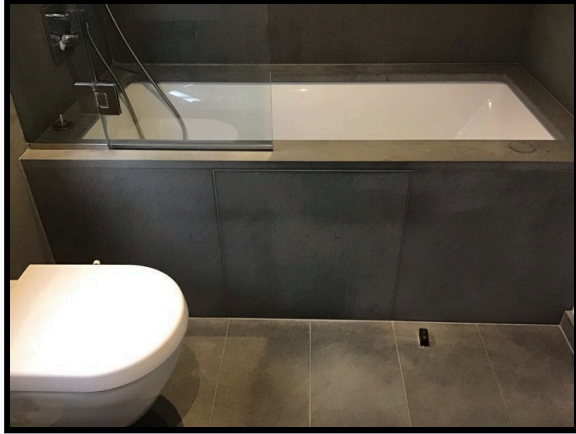
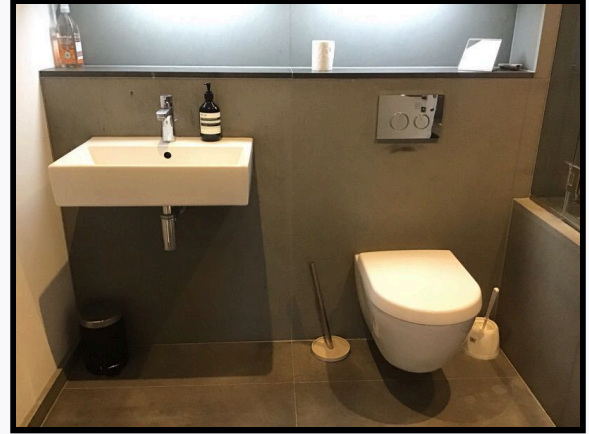
Ref	Name	Description	Condition at Inventory	Condition at Check Out
-----	------	-------------	------------------------	------------------------

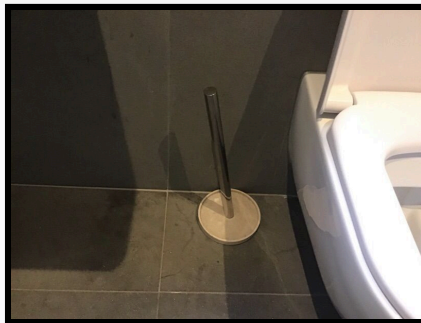
Explain/Repair -
Tenant

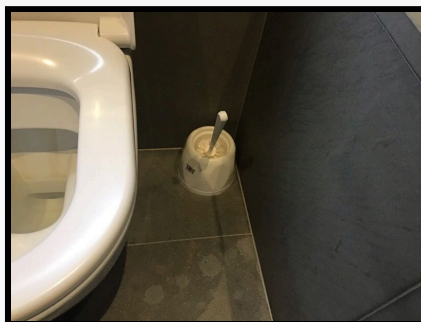
Explain/Replace -
Tenant

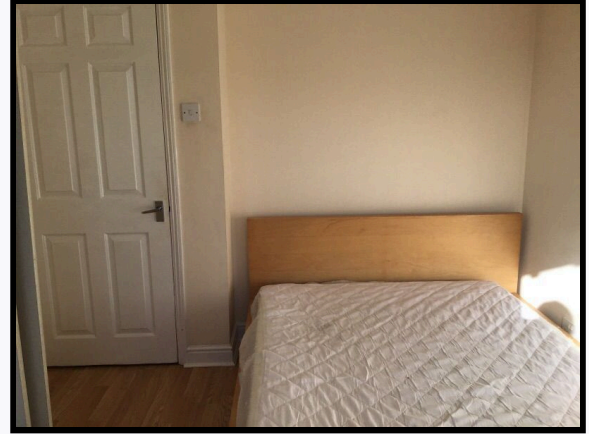
Ref	Name	Description	Condition at Inventory	Condition at Check Out
-----	------	-------------	------------------------	------------------------

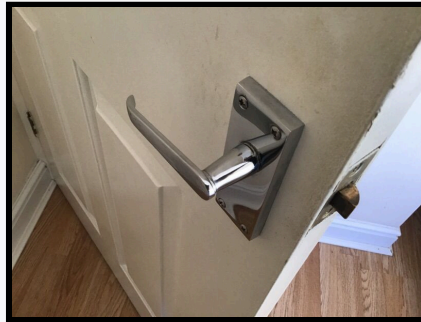
Maintenance - Landlord

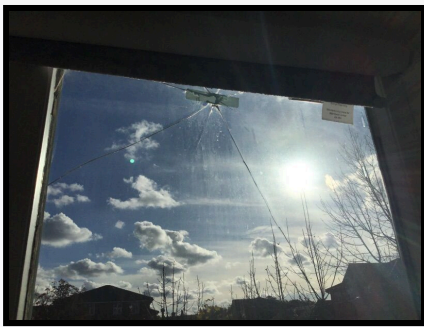
7.7	Window casement	White metal 1 Fixed frame 1 Movable frame Brass lever handle Brass closing arm	Exterior weather soiling	As Inventory + Cracked pane RHS high level - appears cracked from exterior Explain/Repair - Tenant
-----	-----------------	--	--------------------------	---

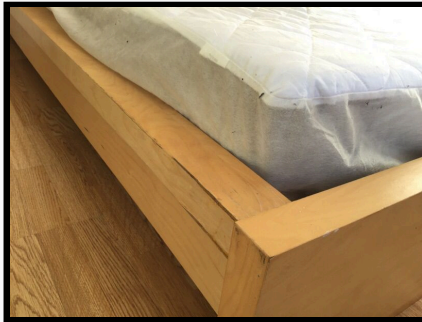
7.15	Single bed	Light wood Matching headboard		Light wear Mattress and protector to top FWT Explain/Remove - Tenant
------	------------	----------------------------------	--	---
