Sample Inventory & Check In Report

123 London Road,
London,
N1 0PP

Visit date: March 9th 2021
Clerk: Property Inventories

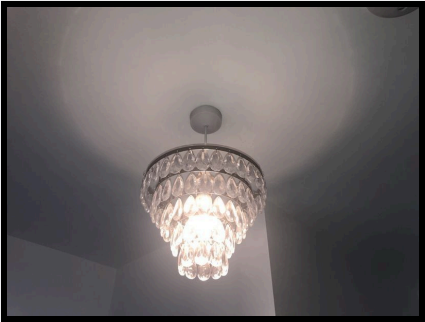
Ref # 6.2		
6.3 Smoke alarm	White Sona	Tested and in WO

Item	Description	Condition
Ceiling		
6.1 Ceiling	Painted white	
Ceiling Mounted Fixtures		
6.2 Ceiling rose, cord, pendant, bulb and shade	White plastic Chandelier style shade	WO

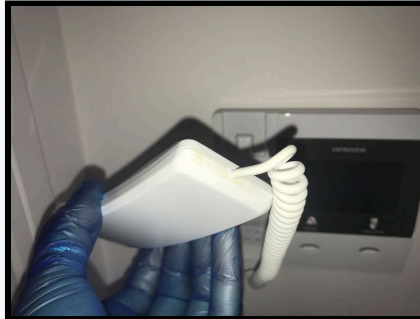
Ref # 6.6

WO
Light residue to receiver

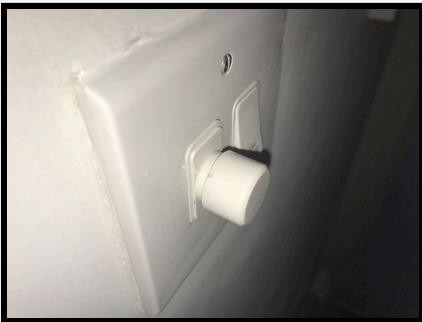
Ref # 6.10

Small chip to dimmer switch button
Light usage marks

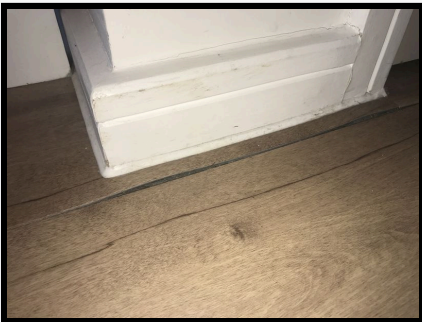
Ref # 6.12

Gapping and lifting to m board to edge LHS of
built-in cupboard

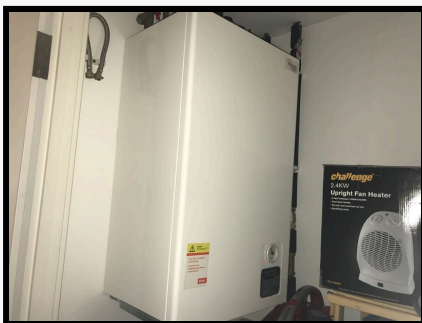
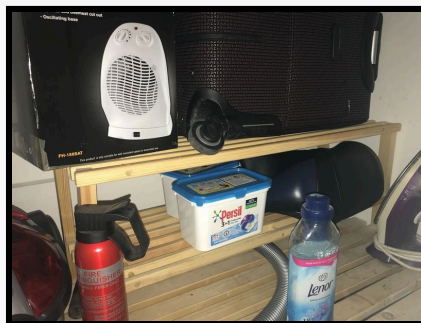
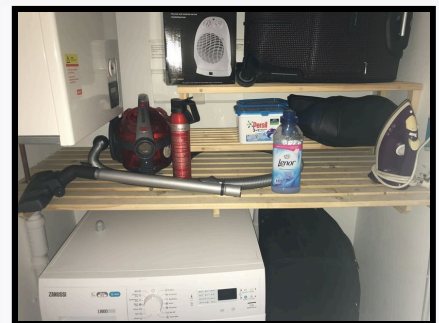
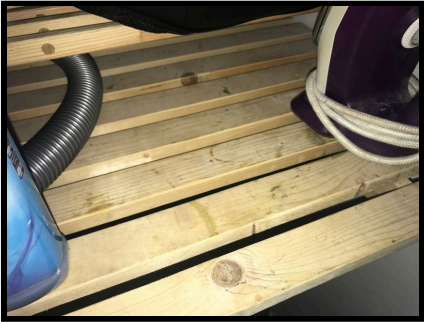
Ref # 6.15

Extractor fan NT
Fuse box cover intact
Ring marks and discoloured marks to shelf
Not fully examined due to tenant's contents

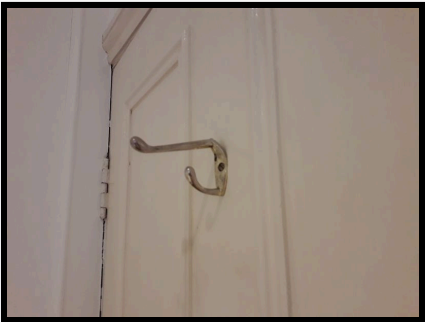
Item	Description	Condition
Door & Architrave		
7.1 Door	Painted white wood 4 Recessed panels	Discolouration to edges Scattered light rubs and scattered paint chips to interior Indentation below interior handle
7.2 Door frame	Painted white wood	Scattered angle chips Light shrinkage cracking to edges Excess paint to edges
Door Fixtures		
7.3 Pair of lever handles	Brass	Light tarnishing and scratches Slight gapping to edges of interior handle
7.4 Double hook	Brass	Light tarnishing and scratches Top hook appears bent down to horizontal position
<div>

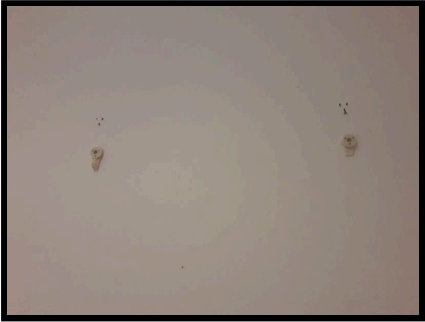
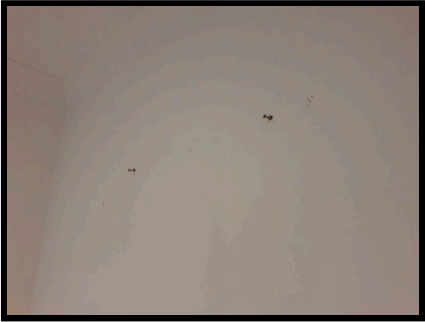
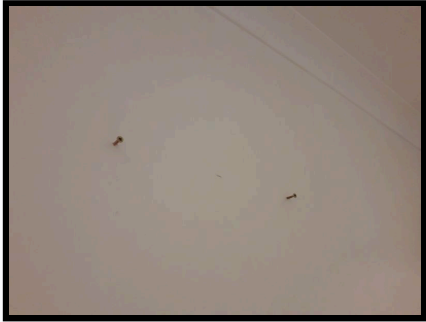
</div> <div>Ref # 7.8Ref # 7.8Ref # 7.8</div>		
Wall Mounted Fixtures		
7.9 Floating shelves	2 White laminate	Scattered angle chips Usage marks Rubs High level shelf not fully examined due to height
<div>

7.6 Coving	Painted white	Light shrinkage cracking to joins and edges in places
Ceiling Mounted Fixtures		
7.7 Recessed spotlights	4 White	All WO Slight gapping to edges of some
Walls		
7.8 Painted	White	Not fully examined due to furnishings Multiple pin holes 2 White plastic hooks and 2 screws to wall LHS of entry door 2 Screws to high level RHS of entry door 2 Notable scuffs RHS of entry door Scattered light rubs and residue spots Patchy paintwork
<div>

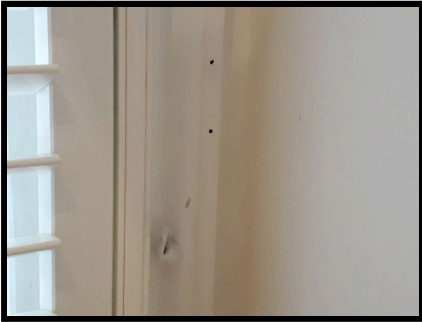
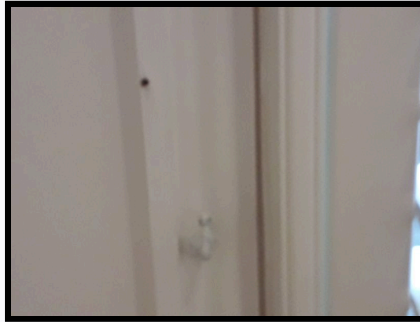
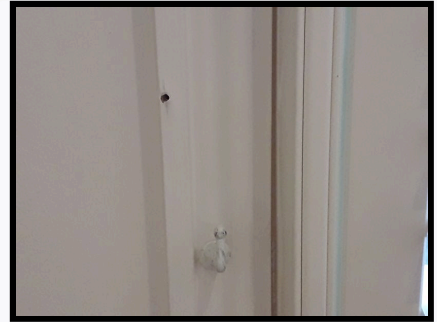
Ref # 7.12

6 Removal holes to high level edge
Removal hole and painted over hook to LHS low level
2 Removal holes and painted over hook to low level RHS

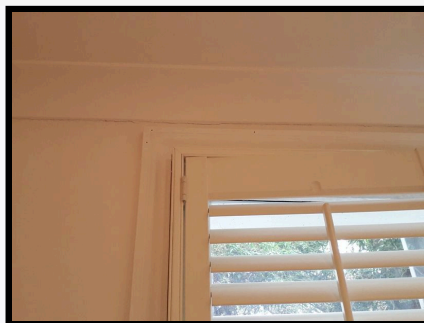
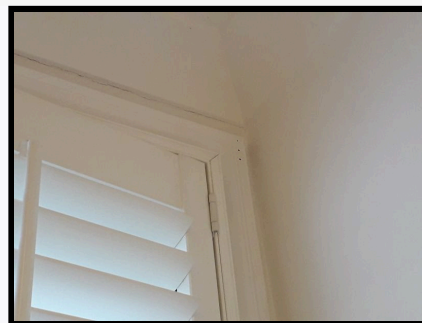
Ref # 7.14

Light dust to recesses

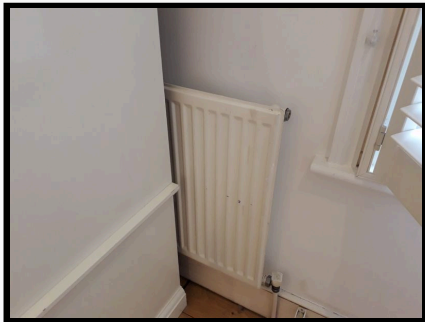
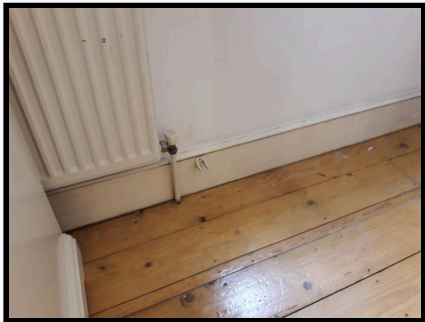
Ref # 7.15

Not fully examined due to furnishings obstructing view - only RHS end cap visible
Appears in WO
Excess paint and chips to RHS

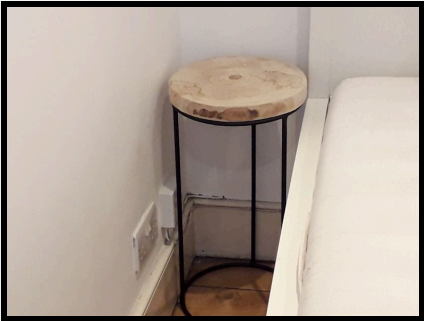
Ref # 7.21

Water marks to top

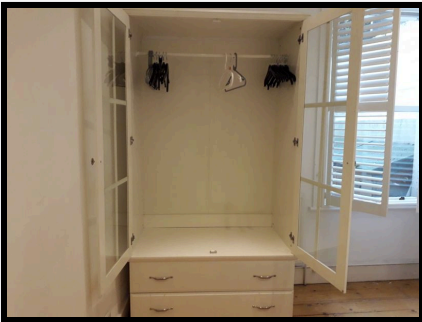
Ref # 7.23

- White laminate
Double doors with glass panelling
2 Full-length drawers
Chrome finger pulls
Chrome D-handles
White metal rail
- Slightly unstable
Usage marks
Light angle chips to base above drawers
Multiple hangers to rail
Light usage marks and scuffs to interior of drawers
Lining paper to drawer bases
Scattered residue spots
Red line to 1 drawer front

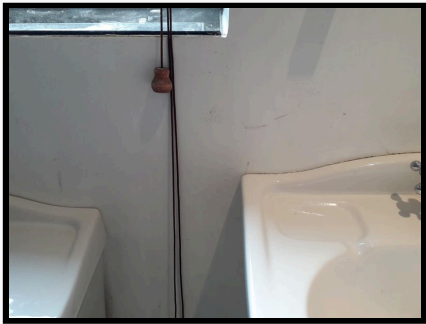
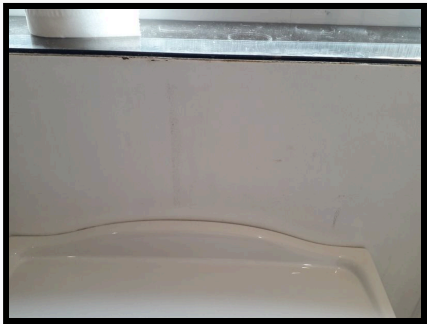
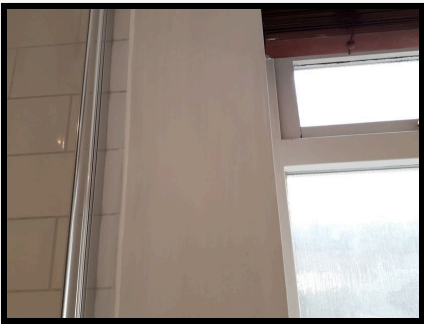
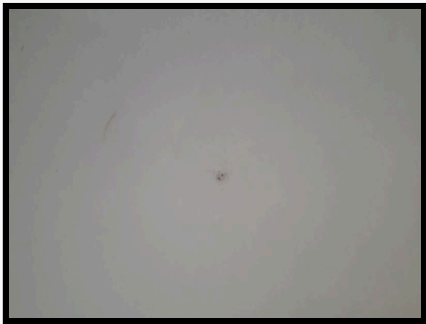
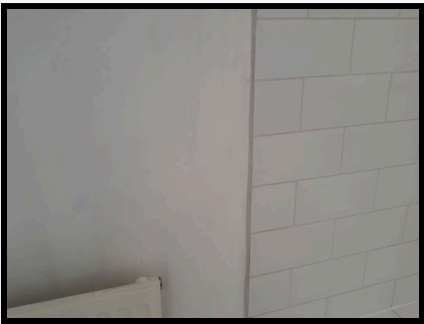
Ref # 8.7

Patchy paintwork
Scattered light rubs
Residue marks, paint cracking and drip marks to mid level above the basin
Faint brown spots to high level RHS of basin
2 Dark discoloured lines above the toilet cistern
Faint drip marks below window sill to LHS
Brush strokes visible LHS of window
Painted over nail above radiator
Brown mark above radiator
Notable patchy paintwork behind radiator
Brown drip marks to mid level RHS of radiator
Drip marks below basin
Paint flaking to low level below towel rail

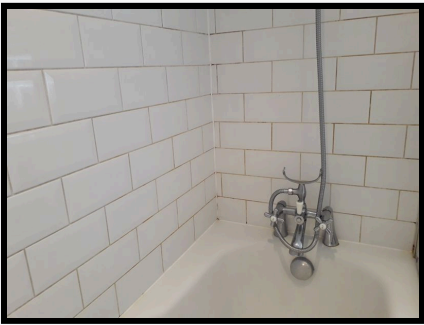
Ref # 8.8

Scattered residue spots
Hair residue
Notable brown discolouration to grout in bath area

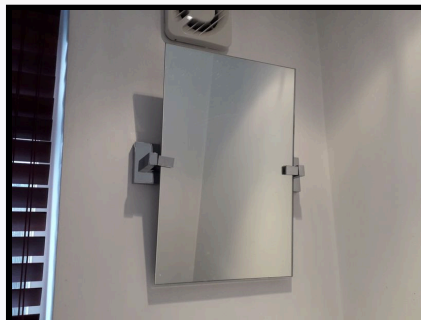
Ref # 8.11

Splash marks to mirror
Light water marks to brackets

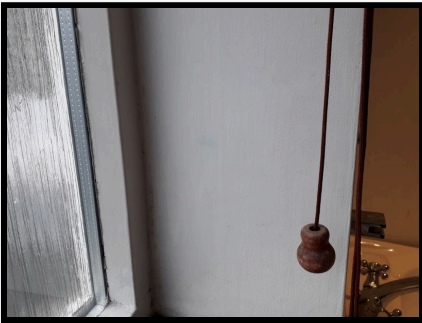
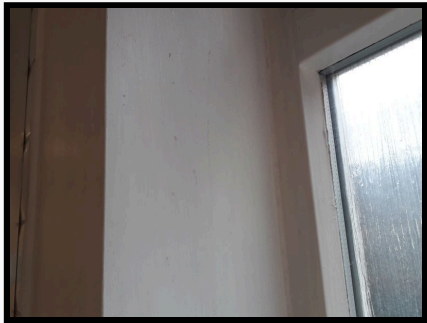
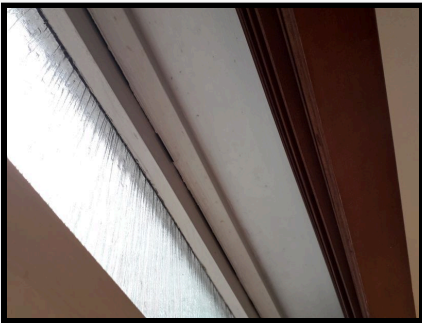
Ref # 8.14

Light paint flaking
White residue to glass
Scattered paint chips and light shrinkage cracking to joins
Brown residue spots to high level frames
Notable chips and tarnishing to handle

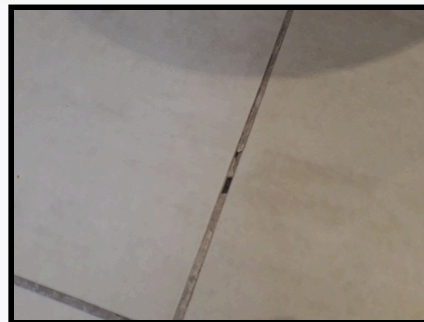
Ref # 8.20

8.20 Tiles	Beige Grey grout	Discolouration to grout Residue Hair residue Cracks and gapping to grout forward of toilet Not fully examined due to furnishings
------------	---------------------	--

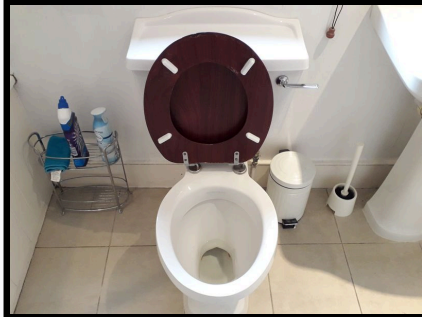
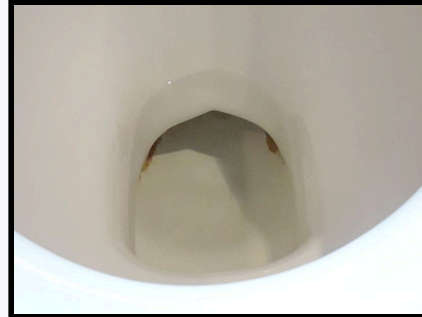
Ref # 8.21

WO
Light soiling below water line
Light soiling and residue to toilet bowl
Faint ring mark to top of cistern

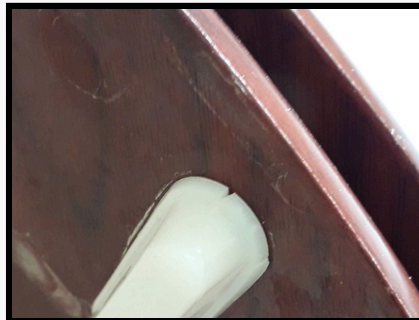
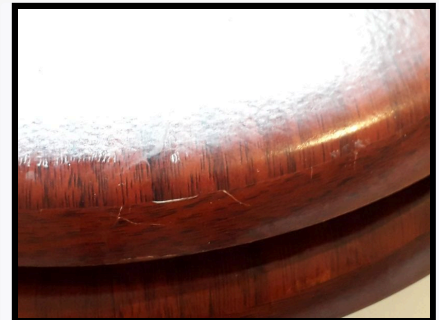
Ref # 8.22

White residue to underside of seat
Small crack to 1 seat buffer
Hinges slightly loose
Light cracks to veneer to front edge of lid

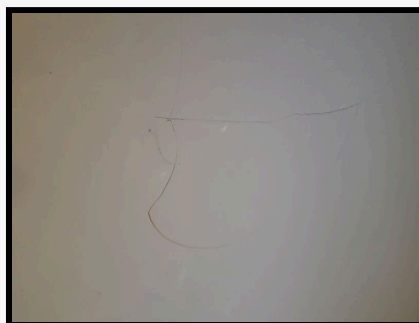
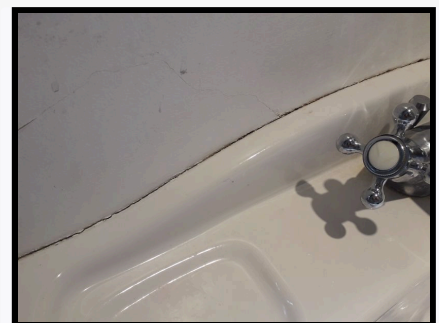
Ref # 8.23

Light soiling
Notable cracks to base of basin
Water marks to chrome fittings
Light soiling to interior of overflow
Gapping to rear sealant behind taps

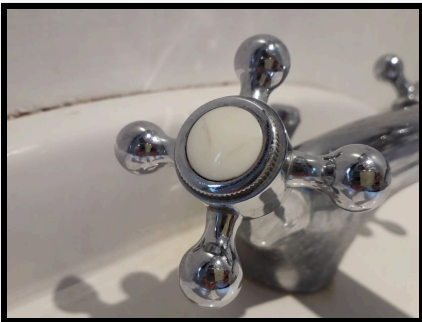
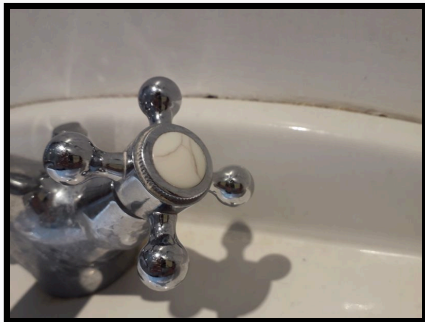
Ref # 8.24

Plug adjuster NW
Cracks to inserts
Water marks and light limescale to recesses

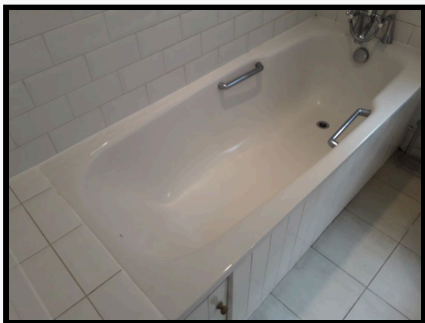
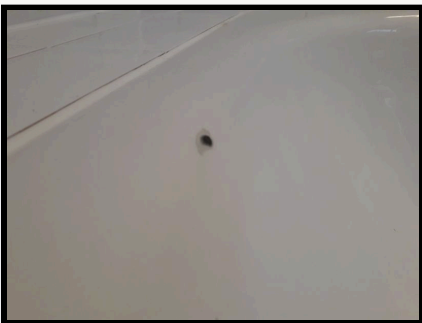
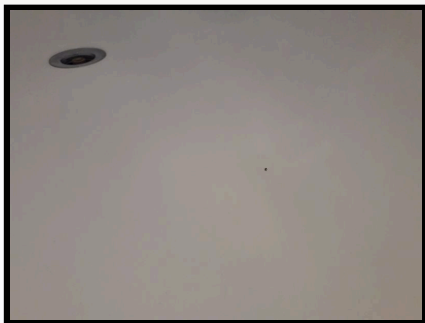
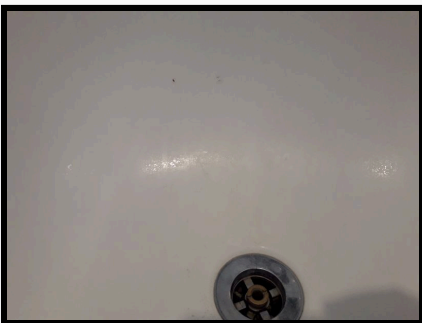
Ref # 8.25

Surface residue
Notable chip to LHS rim
4 Chips around waste
Light scratches and discolouration around waste
Scattered mould spots to sealant
Brown discolouration to base of RHS tap

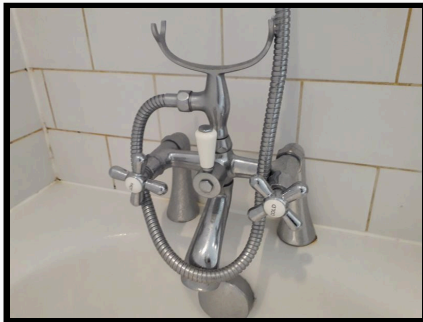
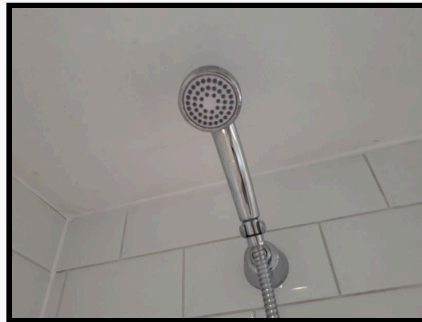
Ref # 8.26

Water marks
Light tarnishing
Light limescale to recesses of flex

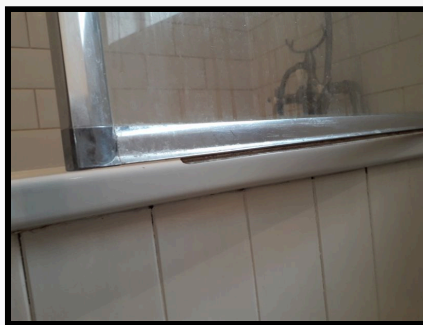
Ref # 8.27

Water marks to glass
Seal appears slightly too short for frame
Discolouration, limescale and possible spots to seal

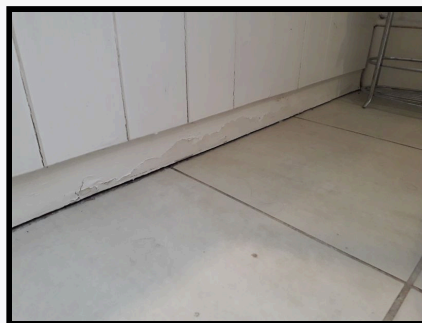
Ref # 8.28

Light shrinkage cracking between panels
Slight discolouration to recesses of some panels
Light wear to finger pull of door
Paint flaking and cracks to low level
Scattered paint chips
Slight water penetration

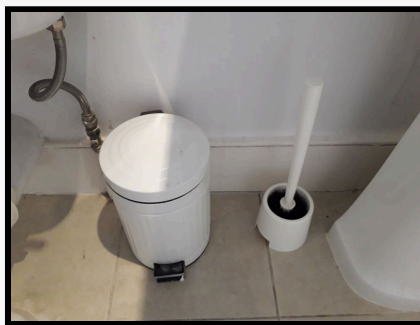
Ref # 8.30

Soiling to top
Light soiling to interior
White residue to pedal
WO

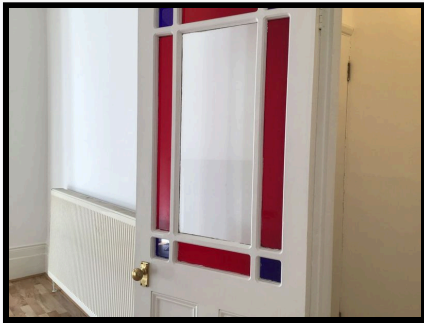
Item	Description	Condition
Door & Architrave		
9.1 Door	Painted white wood 9 Clear, red and blue glass recessed panels 2 Recessed panels	Excess paint spots Light rubs to low level

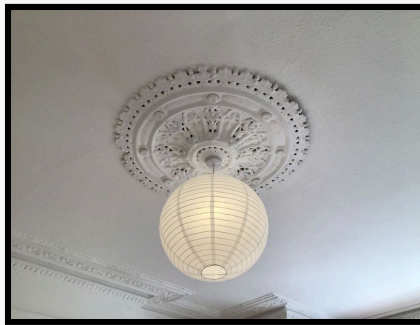
Ref # 9.6

Light gapping to edges in places
Light shrinkage cracking in places

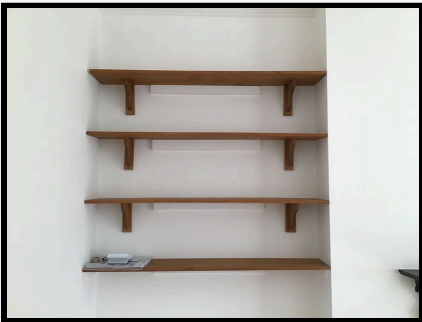
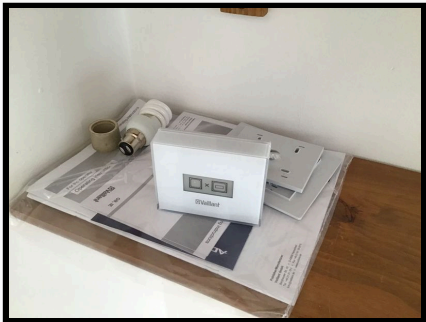
Ref # 9.9

Light wear
Slight bowing to some shelves
Manuals to top
White plastic fixtures to top
Possible freestanding control panel and a light bulb to shelf
Excess paint spots
High level shelves not fully examined due to height
Light scratches in places

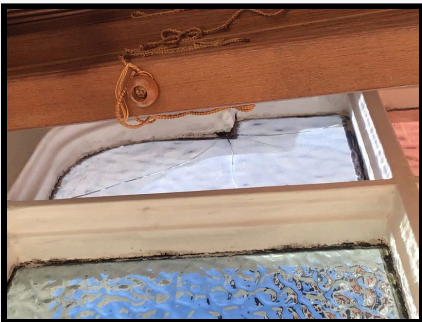
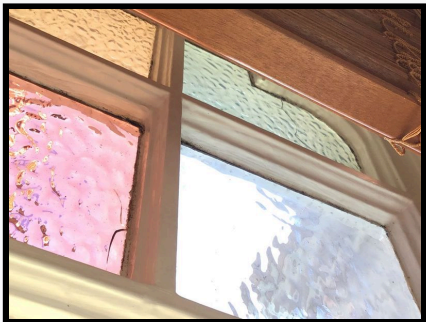
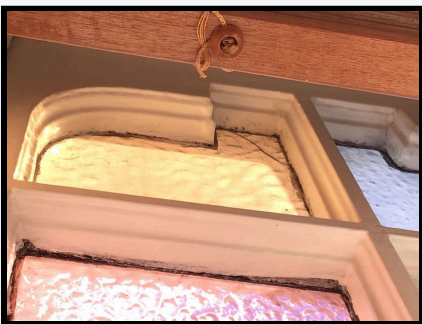
Ref # 9.10

Cords seen to 3 of the windows
Scattered cracks to some glass panels
Light exterior weather soiling
Light mildew and excess paint to edges of all glass panes
Light shrinkage cracking to frames in places
Hole with cabling to low level RHS

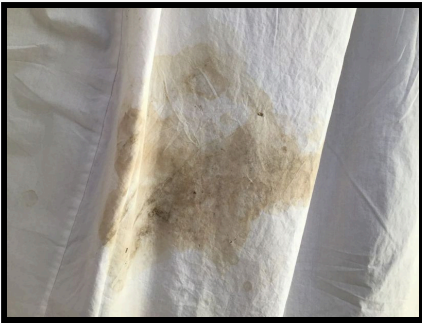
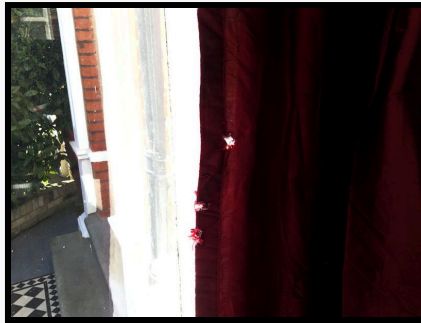
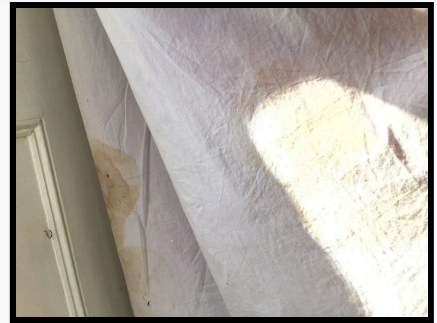
Ref # 9.15

9.13 Curtain track	White metal	Heavily discoloured Appears slightly loose
9.14 Venetian blinds	5 Dark wood-effect laminate Matching cords, acorns and adjuster rods	All in WO Light dust to slats Scattered excess paint spots
9.15 Pair of curtains	Red velvet-effect fabric with white fabric lining Sill-length Grey metal adjuster rod to each	Heavy creases Brown water stains to interior low level lining of both Light fraying and tears to edges of both

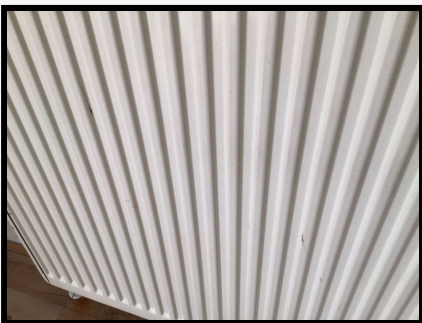
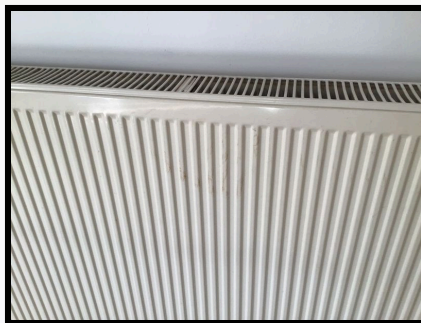
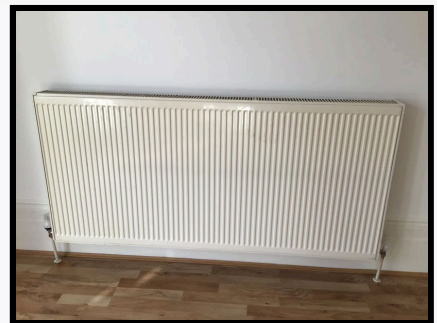
Ref # 9.16

9.16 Double panelled radiator	White manufacturer's finish with grille	NT Both end caps seen Discolouration throughout Rubs Residue Excess paint Scratch to LHS
-------------------------------	---	--

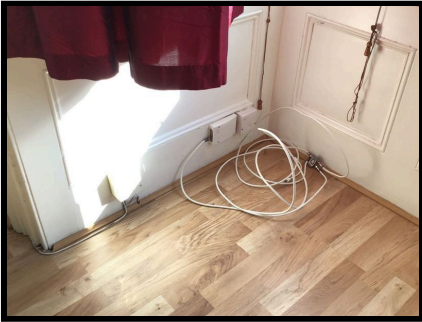
Ref # 9.17

9.17 White plastic switches and sockets as fitted to include:	Dimmer switch Double telephone jack Single telephone jack Virgin Media box TV jack	Light dust to top Light soil spots Light discolouration Excess paint Scratches to brass
---	---	---

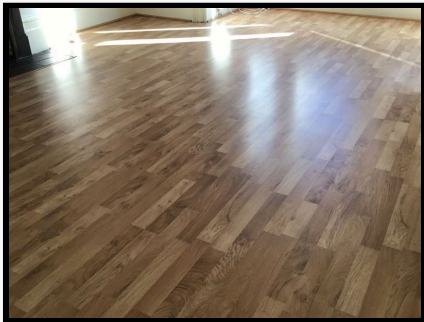
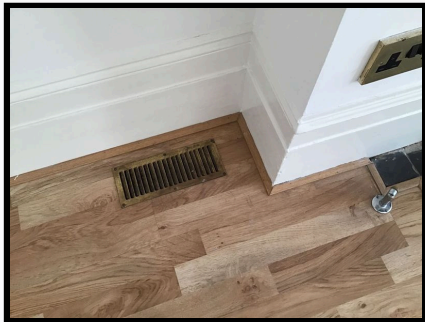
Ref # 9.20

Light debris
Excess paint spots to beading in places
Seams visible to beading
Light gapping in places to beading
Scattered light rubs
2 Pieces of brown tape forward of window
Circular residue and green spot stains forward of window to RHS
Blue stain forward of fireplace
Scattered residue marks
Tarnishing to air vents

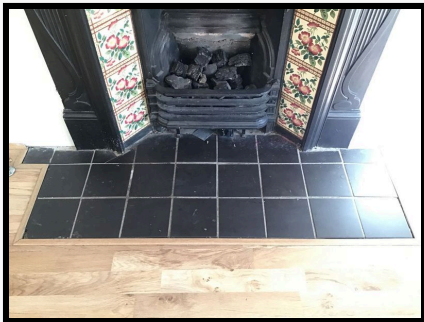
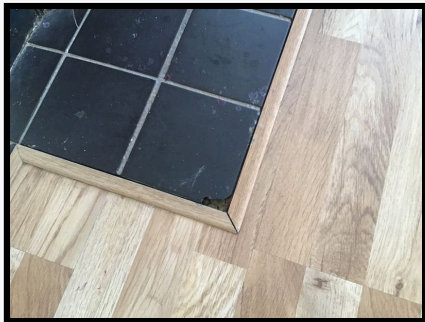
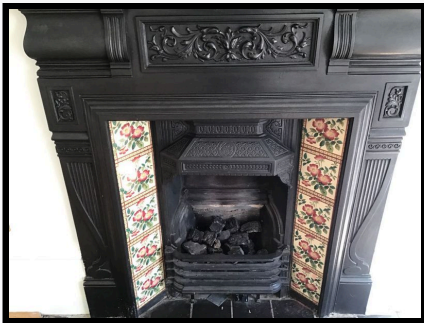
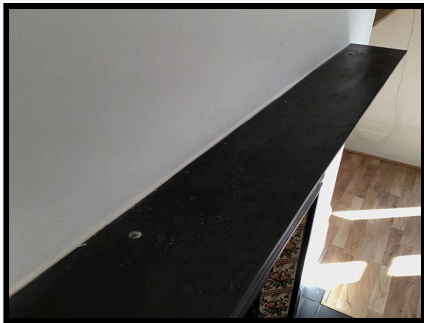
Ref # 9.21

Ring marks, white marks and brown marks to top of mantel
Tiles aged
Light residue spots to tiles
White splash marks to low level
Red candle wax to plinth
Cracked tile and chipped tile to LHS
Light dust, residue spots and wax residue to plinth
Light gapping between plinth and wooden surround with slight gapping to joins of surround

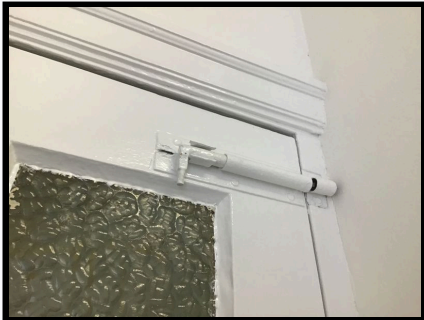
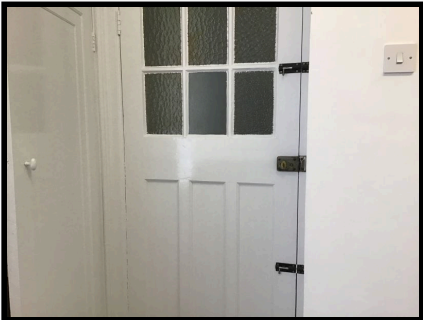
<p>Ref # 10.5</p></div><div>

Item	Description	Condition
Entry Door & Architrave		
10.1 Door	Painted white wood	Angle chip to low level interior
10.2 Door frame	Painted white wood	Painted over defects Angle chip to mid level RHS exterior
Entry Door Fixtures		
10.3 Pair of lever handles	Chrome	Light residue Excess paint spots Screw missing to interior
10.4 Door closer	Grey metal <i>Briton</i>	
Stairwell Door		
10.5 Stairwell Door	Painted white wood 6 Obscure glass recessed panels 3 Wood recessed panels	Painted over defects Excess paint to edges of glass 1 Mis-matching glass panel Residue mark above night latch and receiver
<div><div>

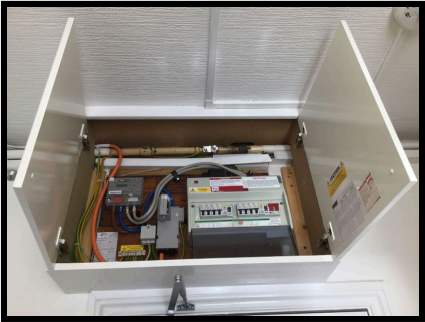
Ref # 10.15

10.15 High level cupboard	Painted white wood Double doors Chrome finger pulls Electricity meter Wylex fuse box	Light painted over defects to doors and frames Light tarnishing to finger pulls Stickers to interior RHS door Cover intact to fuse box

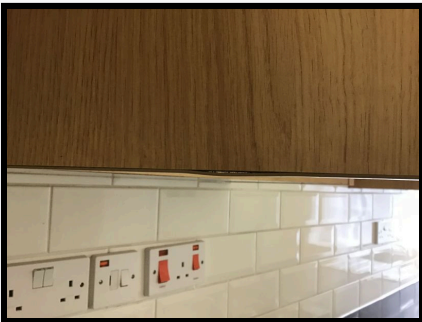
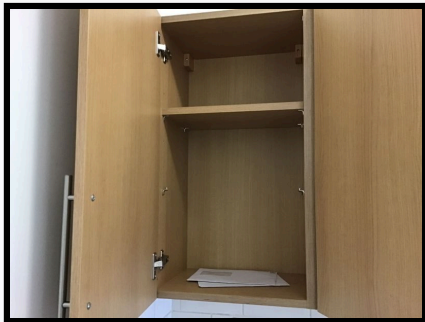
Ref # 10.27

1 Shelf appears missing from far LHS unit
Postal items to interior of far LHS unit
Slight swelling and angle chip to low level RHS corner of door to far LHS unit
Light usage marks
Trim to bottom edge of middle unit is detaching slightly
Scattered residue spots

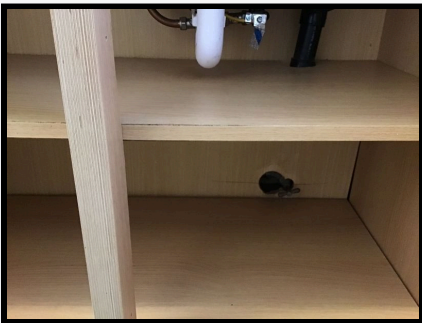
Ref # 10.28

Scattered residue spots
Slight gapping to low level rear wall of double unit
Light swelling and discolouration to double unit shelf

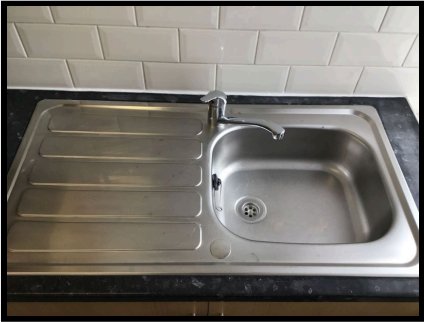
Ref # 10.32

Ref # 10.30		
10.31 Splashback	Beige bevelled-edged tiles Beige grout	Discolouration to grout
Sinks / Taps		
10.32 1 Sink with integrated dish drainer, overflow, waste, and plug	Stainless steel	Cleaning scratches Dark residue spots to drainer Light water marks

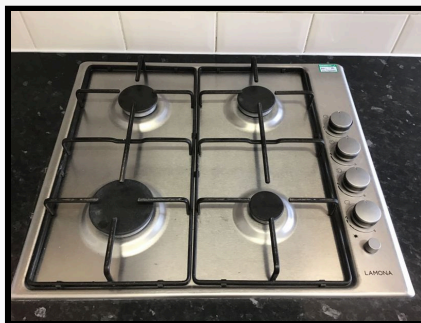
Ref # 10.35

Light scratches
Decals fading
Wear to burners and trivets

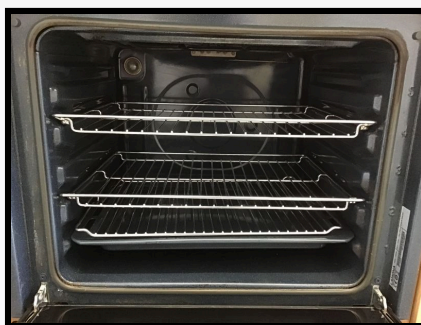
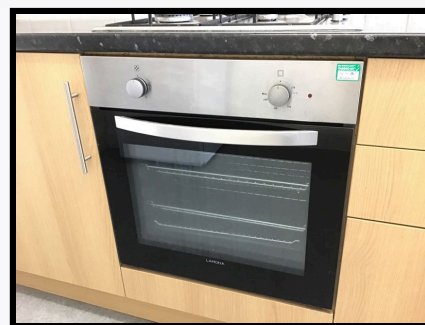
Ref # 10.36

Light smears and scratches to exterior chrome by dials
 Light residue to RHS dial
 Decals fading
 Run marks and food residue to window
 Light burnt on grease to interior and fittings

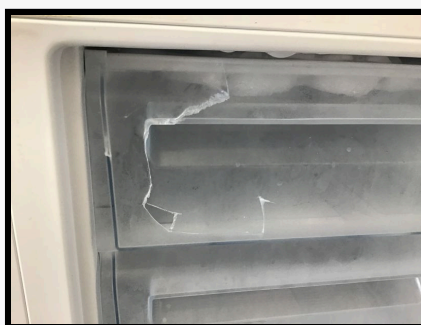
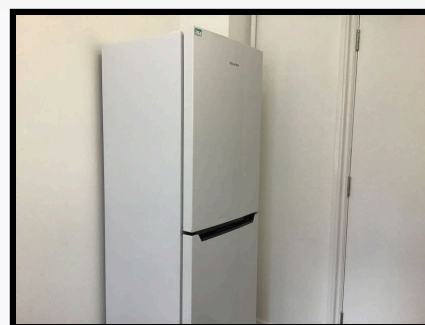
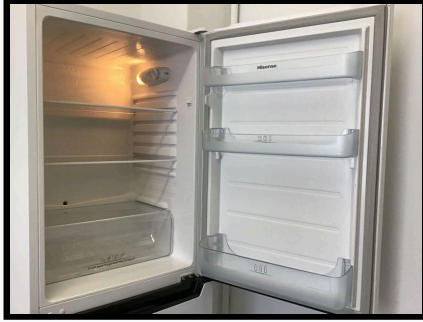
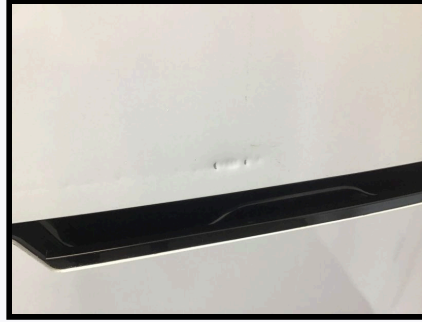
Ref # 10.37

Lights in WO
 Light usage marks
 Dents with chipping and light wear to low level exterior fridge door
 Crack with piece missing to top freezer drawer

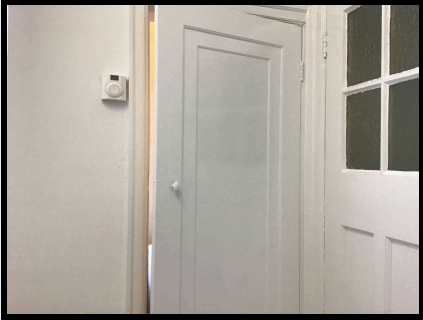
Item	Description	Condition
Door & Architrave		
11.1 Door	Painted white wood Recessed panel	Light painted over defects

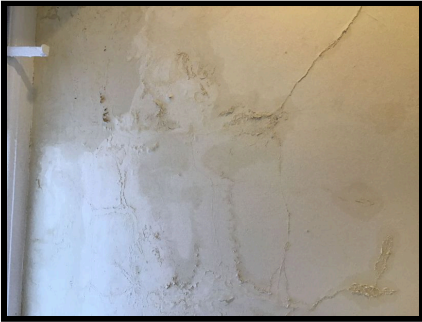
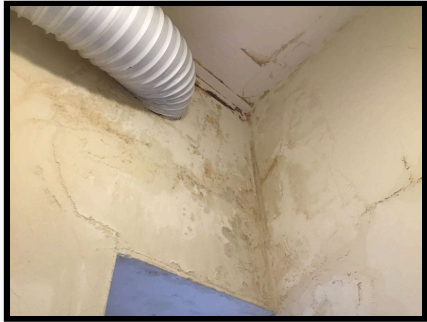
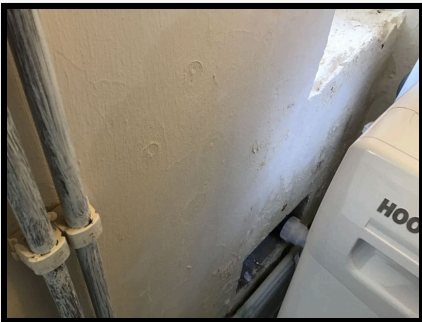
Ref # 11.6

Ref # 11.4		
Ceiling Mounted Fixtures		
11.5 Pendant light	White plastic	WO
Walls		
11.6 Painted	Cream	Heavy brown water stains and bubbling Discolouration throughout

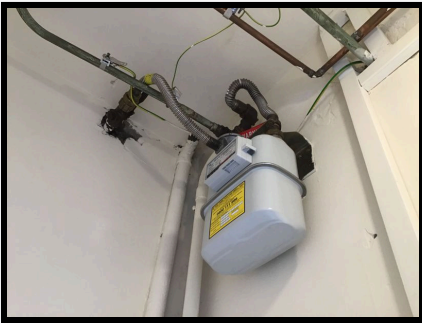
Ref # 11.7

11.7 Gas Meter

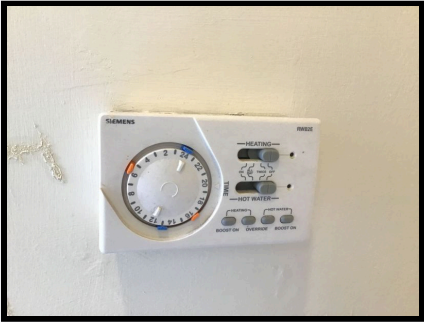
Ref # 11.8

11.8 Heating control panel

White plastic
Siemens

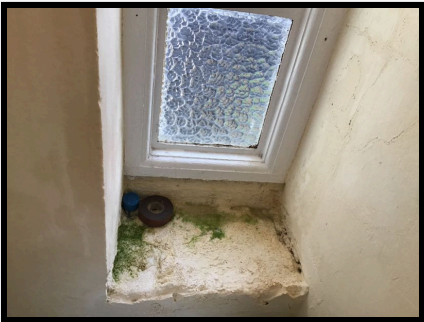
Ref # 11.12

Green discolouration
Uneven
Items to top

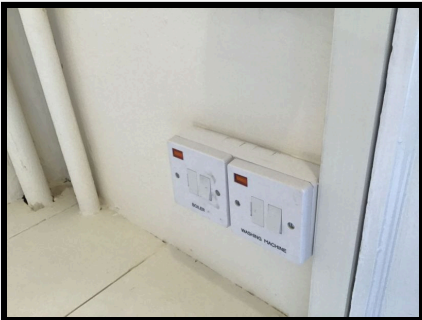
Ref # 11.13

11.13 White plastic switches and sockets as fitted to include:

Washing machine fuse switch
Boiler fuse switch

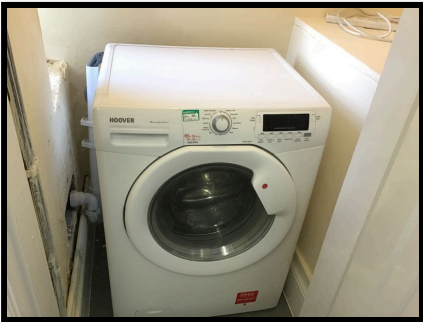
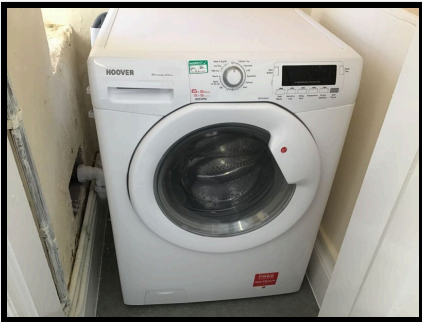
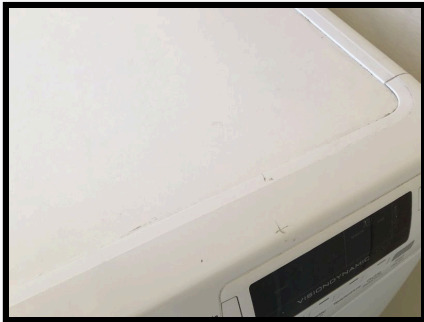
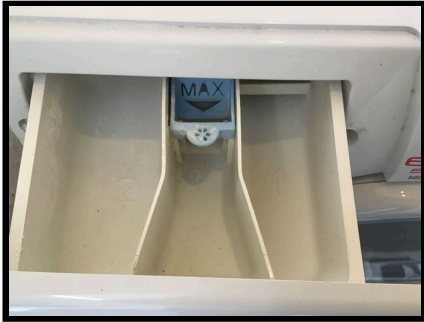
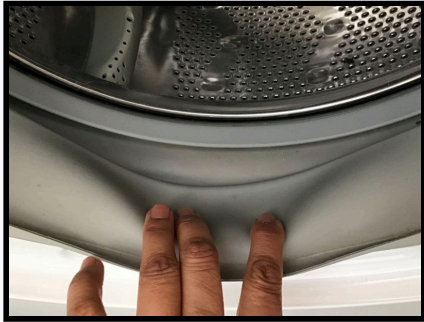
Ref # 11.16

Hoover
Model no: WDYN654D

NT
Light soap residue to tray
Cross-shaped scratch above control panel to
RHS
Few scattered scratches to top

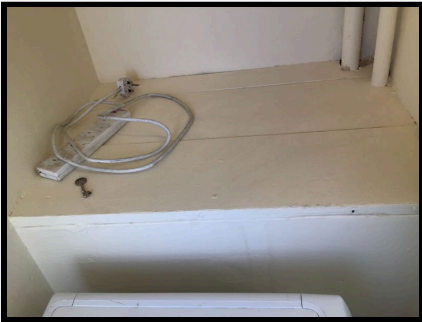
Ref # 11.17

Discolouration

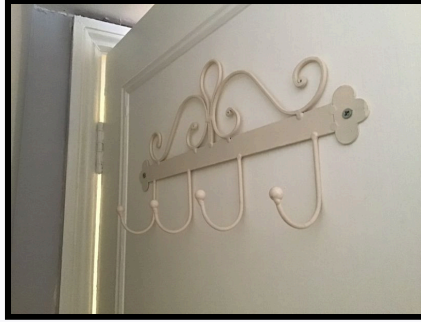
Ref # 12.4

Ref # 12.1		
12.2 Door frame	Painted white wood	Painted over defects
Door Fixtures		
12.3 Pair of lever handles	Chrome	Squeak Light residue Handles slightly loose
12.4 Hook fixture	Cream metal 4 Hooks	Excess paint to edges

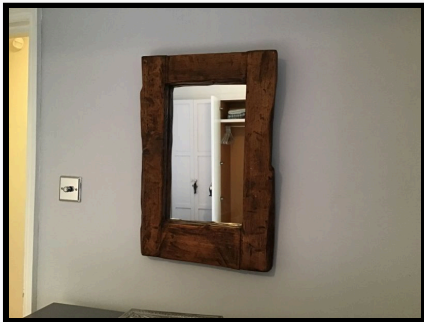
Ref # 12.9

12.9 Mirror	Dark natural wood frame	Filled in holes to RHS of frame
-------------	-------------------------	---------------------------------

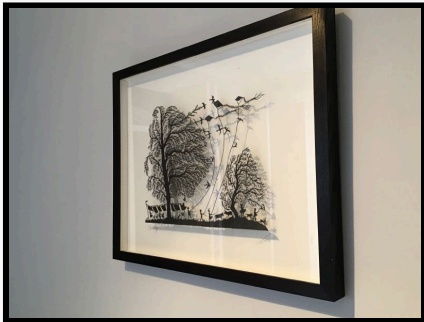
Ref # 12.10

12.10 Artwork

Black laminate frame
Black shadow-effect image of trees, a washing line and kites
Word 'holiday' and signature written in pencil to interior

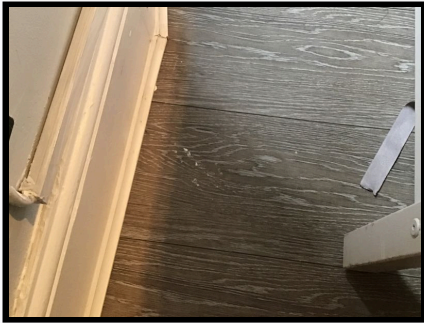
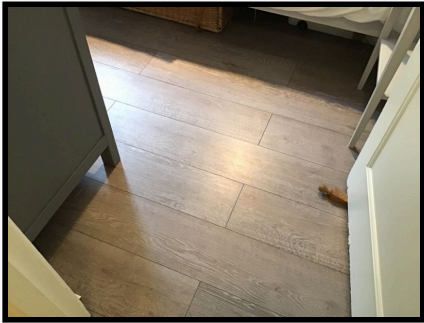
</div> <div>Ref # 12.18</div> <div>Ref # 12.18</div>		
Built-in cupboard

12.18 Floorboards	Grey wood-effect laminate Painted white wood beading Chrome threshold strip	Not fully examined due to furnishings Slight gapping to beading joins White spot marks forward of window
<div>

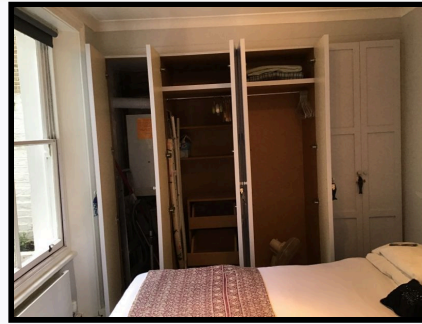
Ref # 12.19

4 Fish-shaped fobs and shells with bells hanging from some finger pulls
Double doors to far RHS currently locked - unable to examine interior
Light rubs to interiors of doors
Light painted over defects
2 Low level hinges on 2nd door from LHS appears detaching
Light scratches around finger pulls

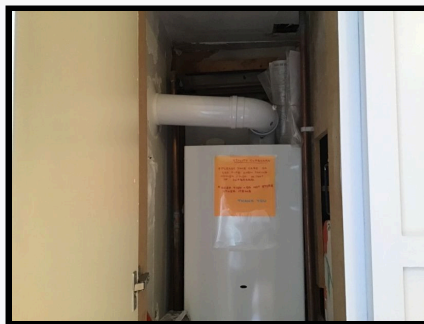
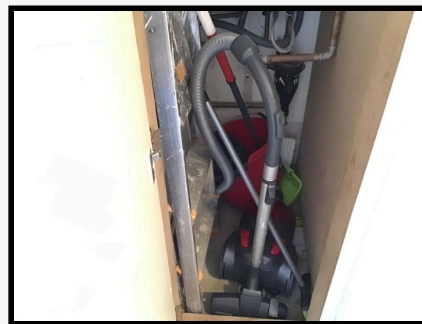
Ref # 12.21

White manufacturer's finish **Biasi** boiler
Clear plastic wallet with orange note stating 'utility cupboard - please take care of gas pipe when taking hoover/mop in/out of cupboard' and another note stating 'keep tidy - do not store other items, thank you'
Grey metal stepladder
Grey and red plastic **Hoover** vacuum cleaner with associated fixtures
Red plastic bucket
Red handled mop
Grey handled small broom
Green plastic dustpan
Clear plastic wallet containing documents for property

Light soiling to boiler control panel cover
Boiler NT
Heavy paint marks and usage marks to stepladder
Wipe marks to vacuum cleaner fixtures
Light dust to vacuum cleaner
Handle detached from dustpan

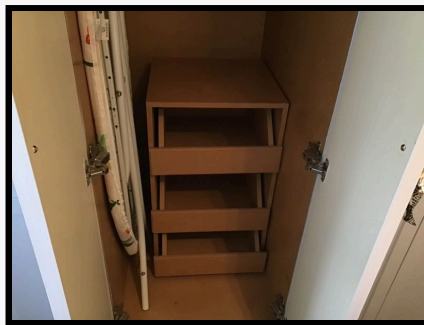
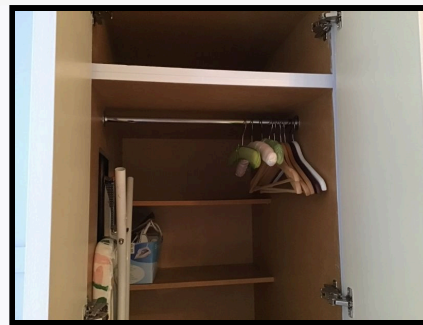
Ref # 12.23

Grey painted shelf
2 Medium wood shelves
Medium wood cluster of 3 drawers
Chrome rail
White and purple plastic **Steamworks** iron
Grey painted shelf
2 Medium wood shelves
Medium wood cluster of 3 drawers
Chrome rail
White and purple plastic **Steamworks** iron
White metal ironing board with white floral patterned cover

Not fully examined due to contents
Excess paint spots in places
Multiple hangers in situ to rail
Iron is inside a box

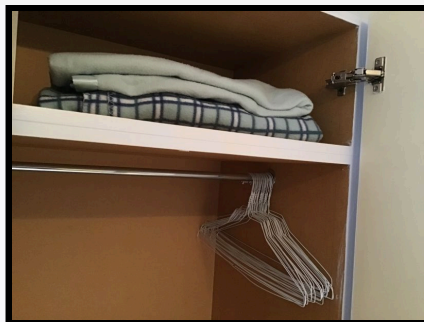
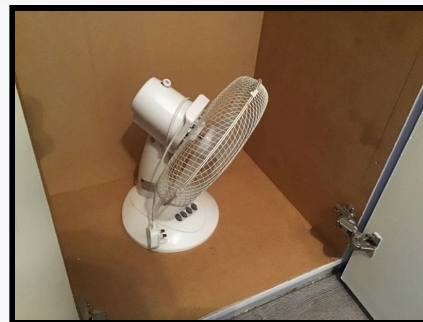
Ref # 12.25

Painted grey shelf
Chrome hanging rail
Green blanket
Green chequered patterned blanket
White table fan

Tape residue to underside of shelf
Multiple hangers in situ to rail
Table fan NT and dusty

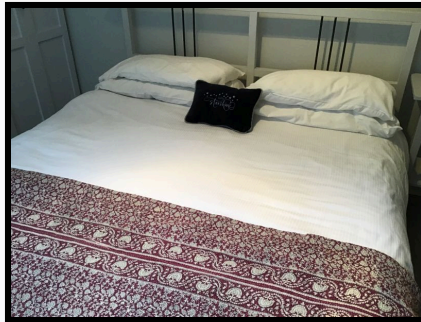
Ref # 12.27

12.27 Mattress

Cream fabric

Not fully examined due to bed being made

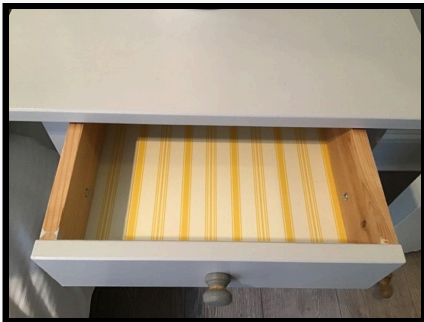
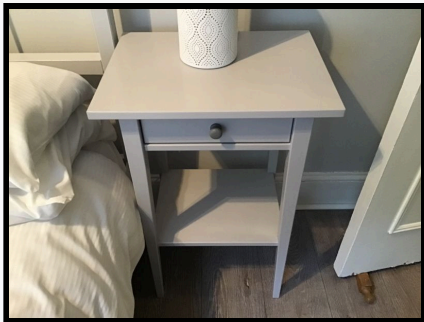
Ref # 12.36

Painted grey wood
Yellow and white striped interior
Drawer
Shelf
Matching finger pull

Slightly unstable
Light chips to shelf
Paint chips to shelf

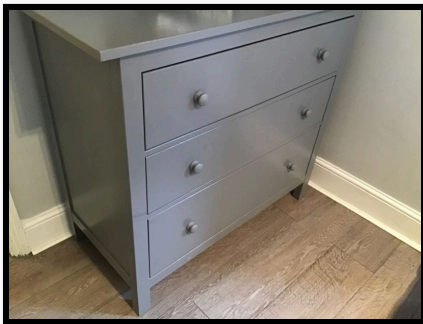
Ref # 12.37

12.37 Chest of drawers

Painted grey wood
Yellow and white striped interior
3 Drawers
Matching finger pulls

Wipe marks to top
Scattered angle chips
Light paint chips to low level

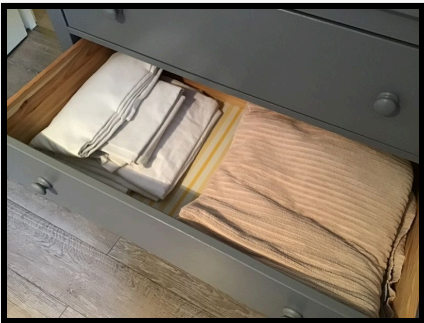
Ref # 12.43

White fabric

Not fully examined due to being folded up

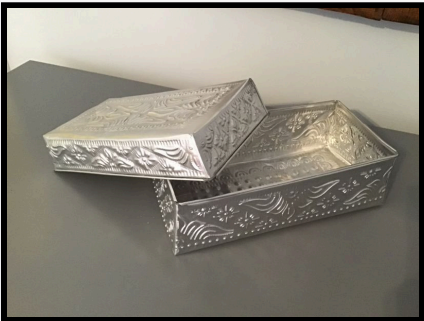
Ref # 12.44

12.44 Storage box

Decorative
Chrome

Heavily dented

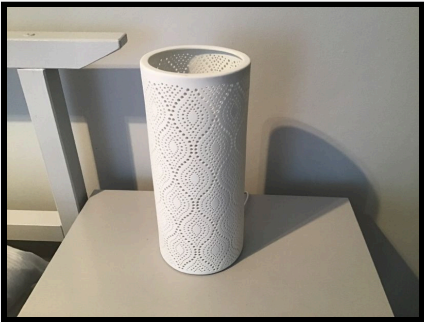
Ref # 12.45

12.45 Table lamp

White ceramic with holes

NT

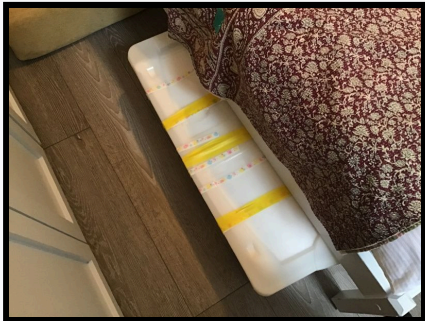
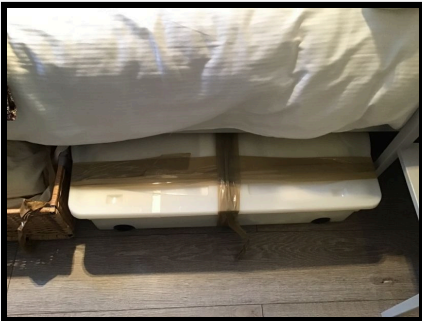
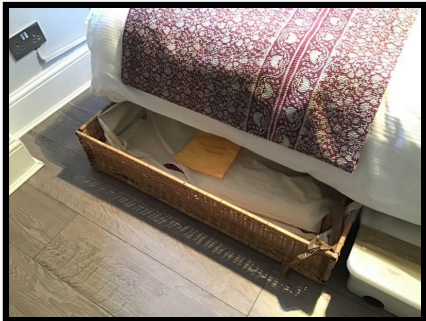
Ref # 12.47

2 White plastic
Black wheels

Both sealed with tape
